## Forensic Subsurface Evaluations, LLC

FSE Project No. 52222-297

**Re: Report of Geotechnical Assessment**  
**The \_\_\_\_\_ Residence**  
**150 Meridian Way**  
**Clinton, Tennessee 37716-6366**  
**Claim No. 10000114982**

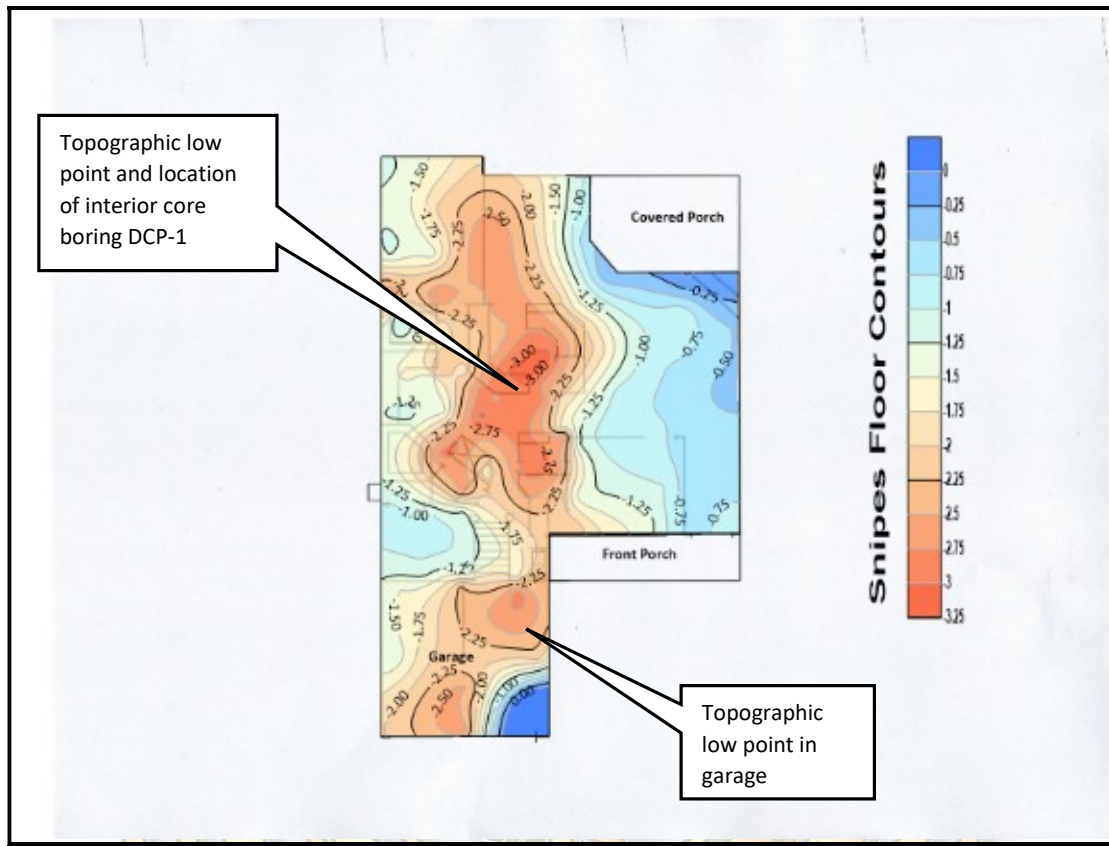
**Figure 2: Relative Elevation Floor Contour Map.**

Garage floor slabs and other concrete slab appurtenances adjoining the structure, are typically cast, and finished to incorporate an inclined surface to shed water away from the structure, should these surfaces become wet.

- In this case, the measured topography doesn't represent typical construction intent.
- It is our opinion that the anomalous measured topography on the garage floor slab surface represent poorly controlled construction and concrete finishing practices, combined with settlement in the central to northern portions of the garage slab.

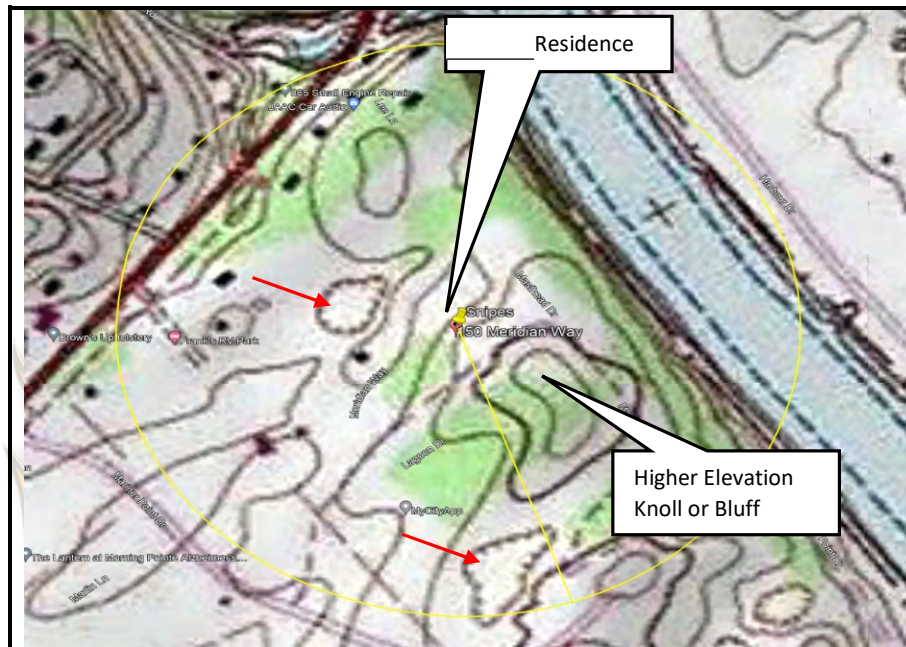
**Figure 3:** Mapped Closed-Circular Depressional Features Within ¼-Mile of the \_\_\_\_\_ Residence.

- Sometimes, when features as these have subsurface connectivity with other, similar dissolution features, particularly if geographically clustered such as within the boundaries of a watershed, these land surface karst features can play important roles for stormwater management and flood control.
- As shown on **Figure 3** below, two (2) mapped topographic low lying depressional features, suspected to have been formed by the dissolution of the surface of the underlying carbonate bedrock, occurred within one-quarter mile of the \_\_\_\_\_ residence.

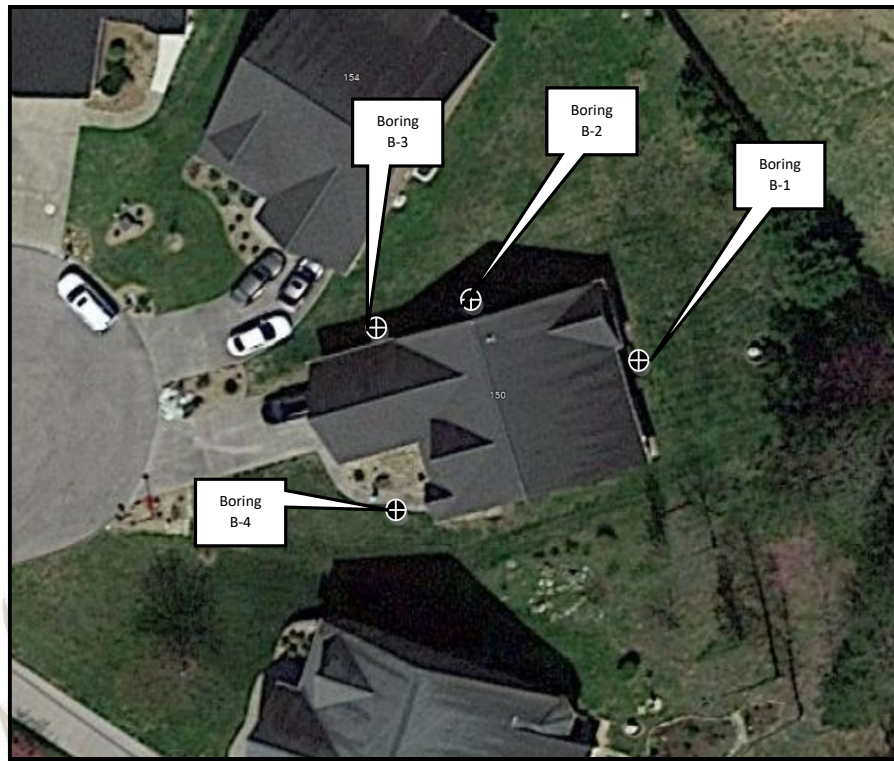
**Figure 4: SPT Boring Location Map**

At the locations shown below on **Figure 4**, FSE performed four (4) drill-rig driven subsurface exploration test borings (Borings B-1 through B-4), with each boring positioned near the exterior perimeter walls where either damage was observed or where downward trends in the measured floor topography occurred near the perimeter walls.
