## Home Inspection Report

PROPERTY INSPECTED:  
**5916 Meadow Oaks Lane**  
**Knoxville, TN 37920**

**Date of Inspection: 01/18/2024**

Inspection No. 351436-1291

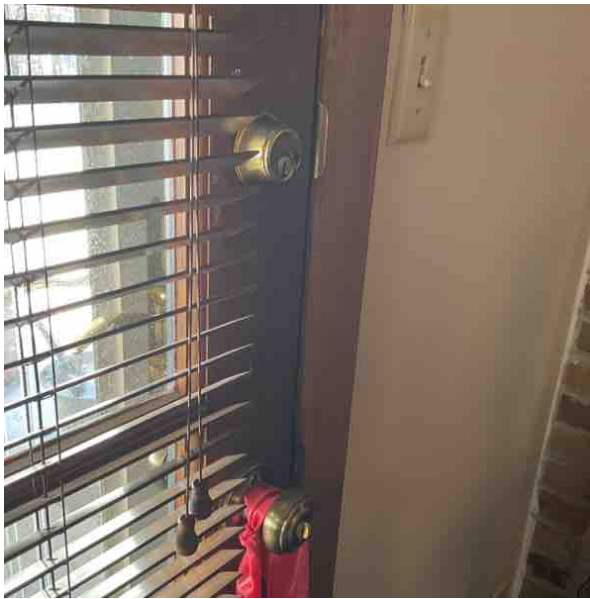
3.6.2 **The exterior door was keyed on both sides. This configuration is a safety hazard in the event of a fire egress. Modern safety standards require no special tools, knowledge, or keys to egress a home. Recommend replacing the deadbolt with an appropriate lock for the safety of occupants and guests. (den)**

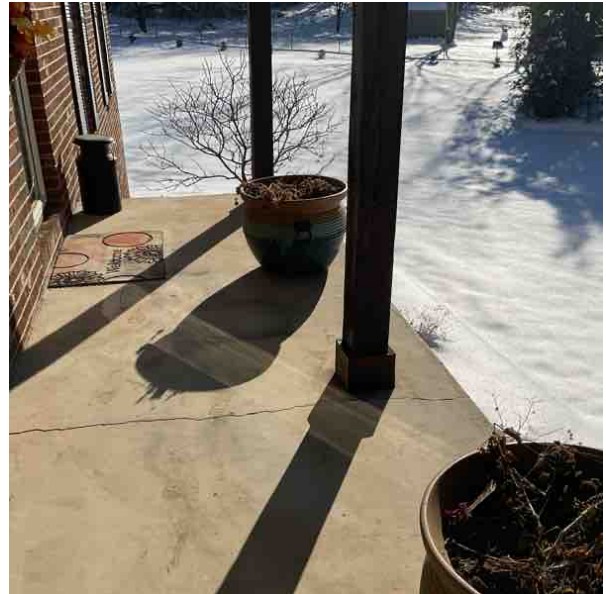
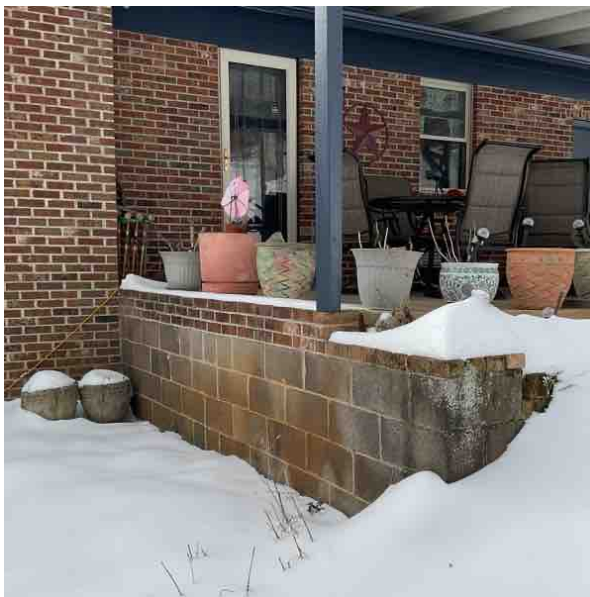
- Exterior Back
- Exterior Front

**3.7.2 The drop off height of the porch exceeded 30" with no installed guards. This is a fall safety hazard especially for children and those with reduced mobility. It is recommended to have guardrails installed where required by a qualified contractor for the safety of occupants and guests.**

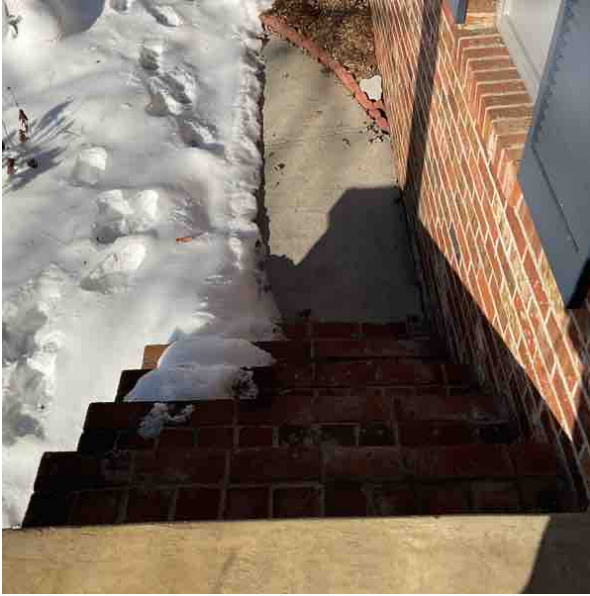
**3.7.3 The stairs had four or more steps with no handrail / guardrails. This is a fall risk especially for children and those with reduced mobility. It is recommended to have handrails installed where required by a licensed contractor for the safety of occupants and guests. (Exterior Front)**

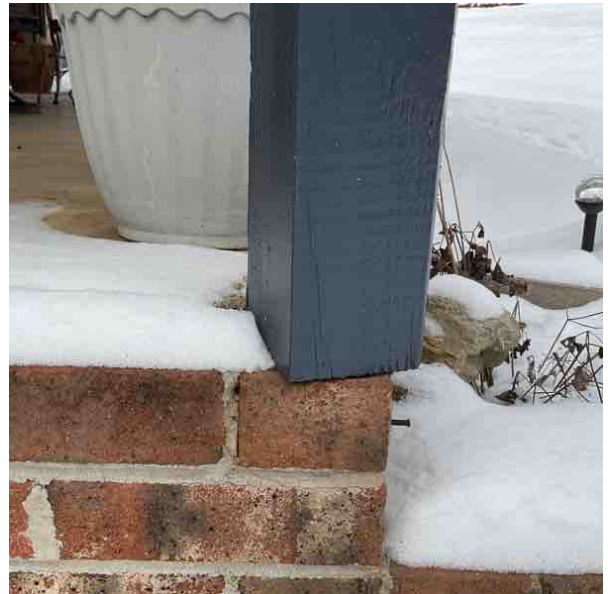
**3.7.4 The porch roof posts were not attached at the bottom. This condition has allowed one of the posts to rotate and may develop into unsafe conditions. It is recommended to have a further evaluation and corrections as needed by a qualified contractor to prevent any possible damage. (Exterior Back)**

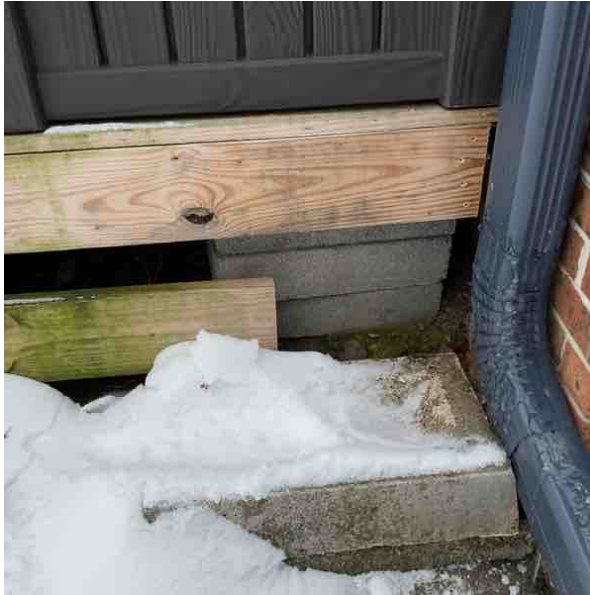
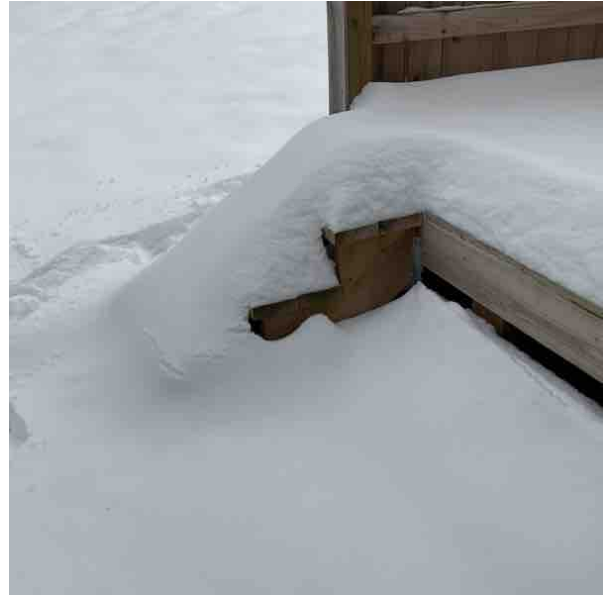
**3.8.1 The construction of the deck did not meet current industry standards. A partial list of concerns includes:**

- There were dry stacked blocks used as posts.
- The stair riser connectors were connected with deck screws.

It is recommended to have a further evaluation and corrections as needed by a qualified contractor for the safety of occupants and guests. (Exterior Right)

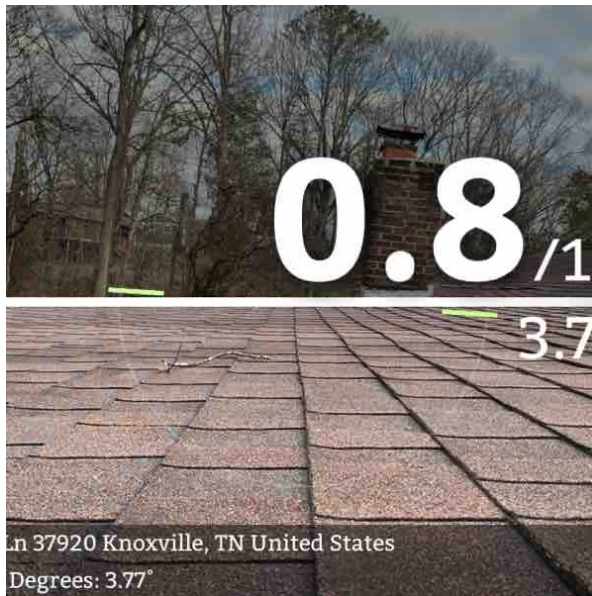
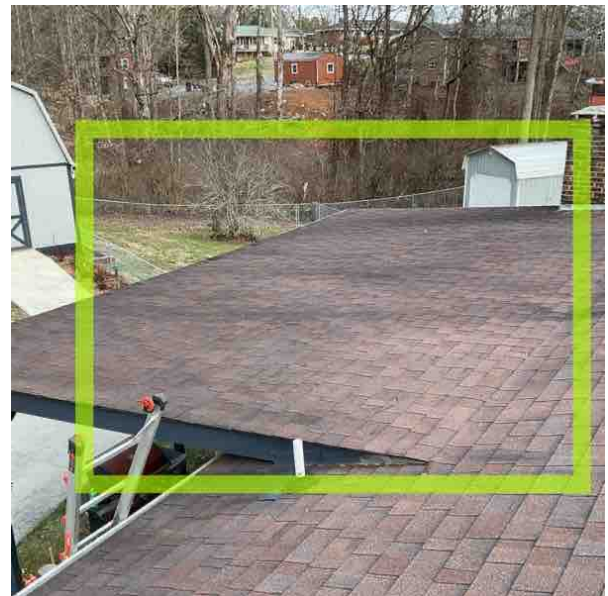
4.4.2 There were asphalt shingles were installed on a roof with a slope with less than 2 inches of vertical rise in 12 inches of horizontal run (2&12). This is a defective installation. The defective area was limited to the front porch sections. Generally-accepted current standards and most manufacturer's installation recommendations are that asphalt shingles not be installed on roofs that slope less than 2 & 12. This condition increases the chance of roof leaks and may void any existing shingle manufacturer's warranty that might otherwise be in effect. Recommend contacting a licensed roofer to discuss options for correction.

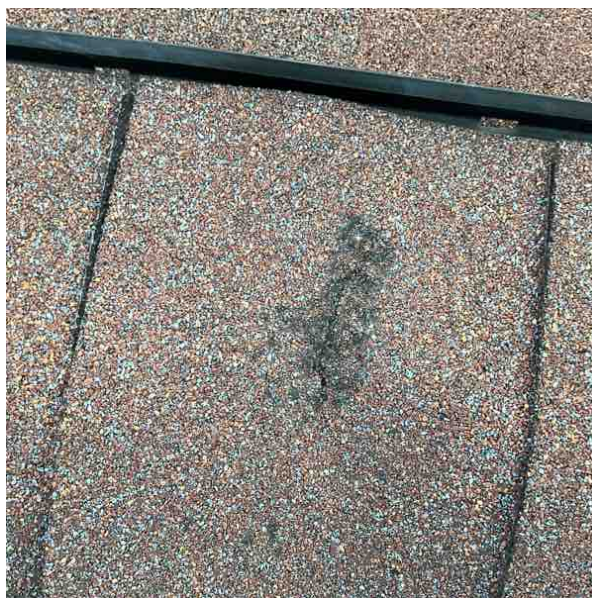
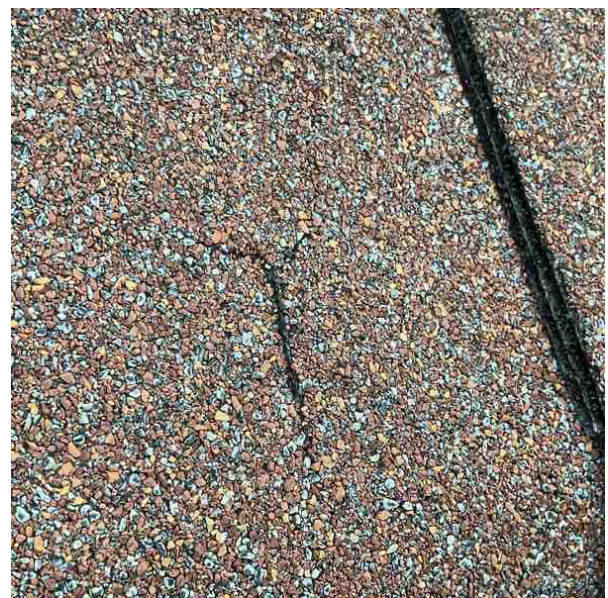
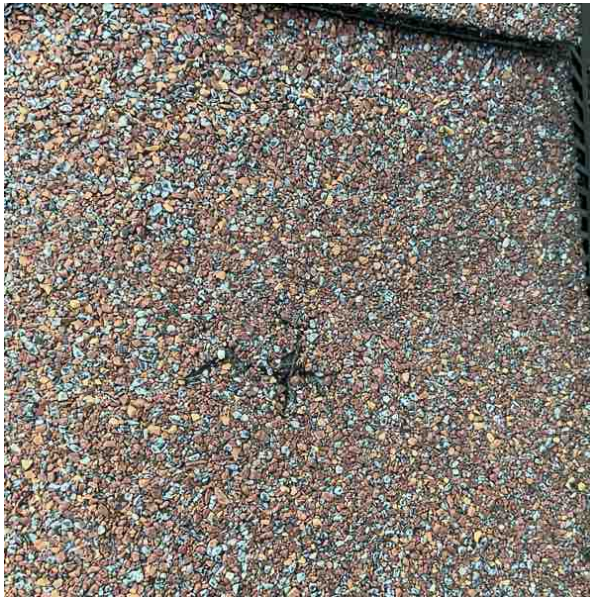
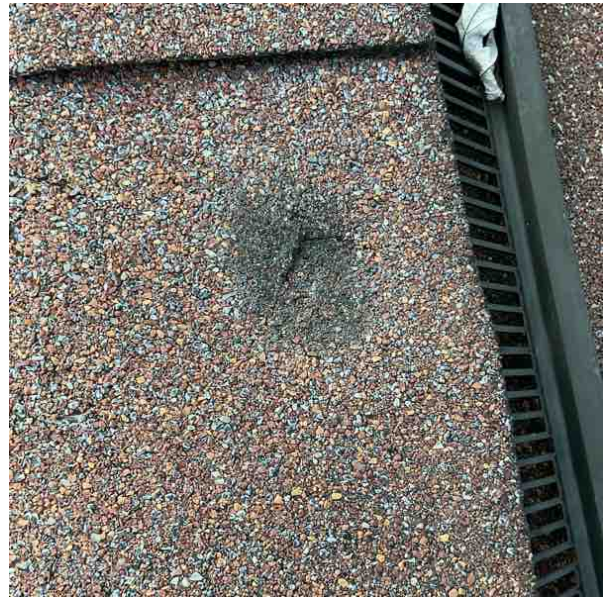
4.4.3 There were damaged (cracking, splitting, missing, curling, lifting, etc.) shingles on the roof. Recommend correcting by a licensed roofer to prevent water-related damage to structure and interior finishes.

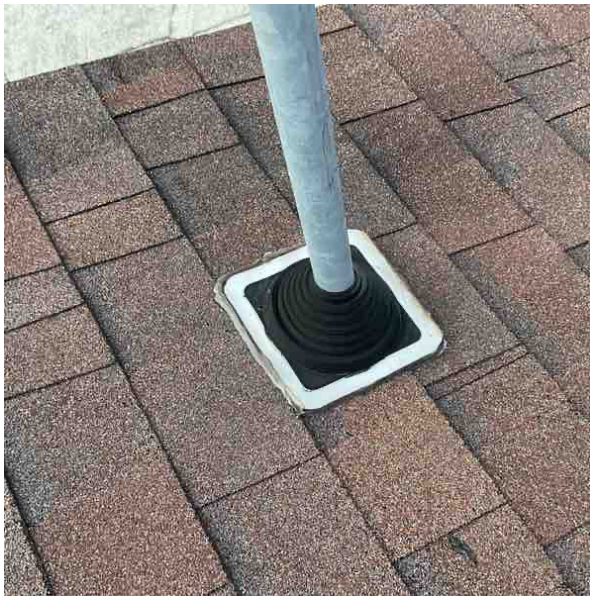
4.5.1 **The flashing was inappropriate for the roof shingles. It is recommended to have the flashing corrected by a qualified contractor to prevent any moisture intrusion into the interior surfaces.**

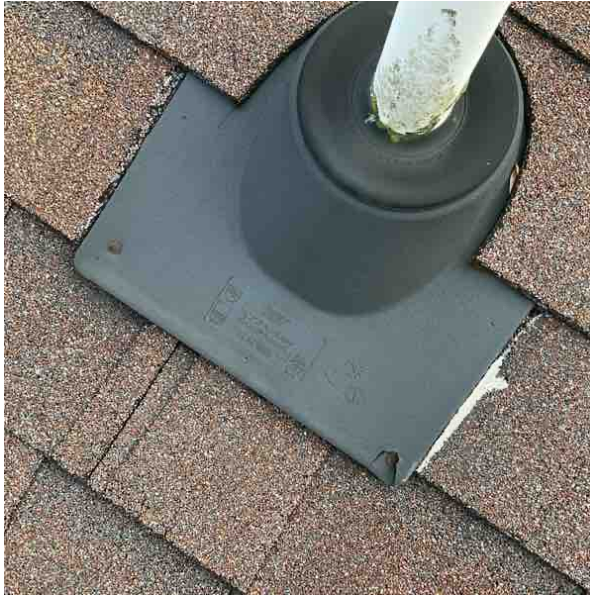
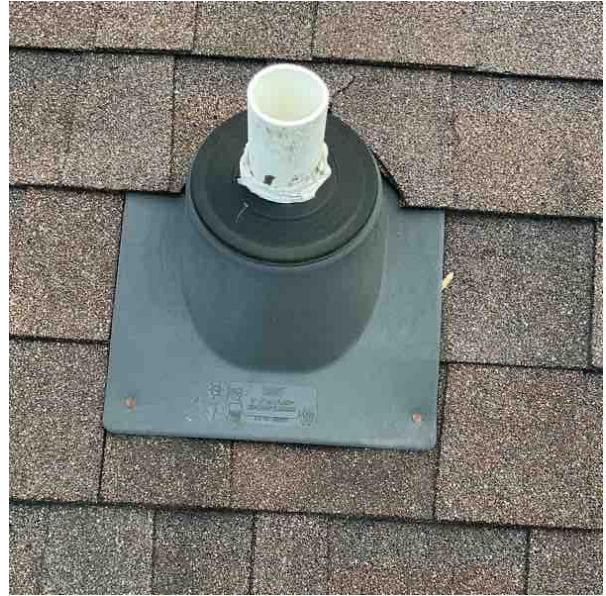
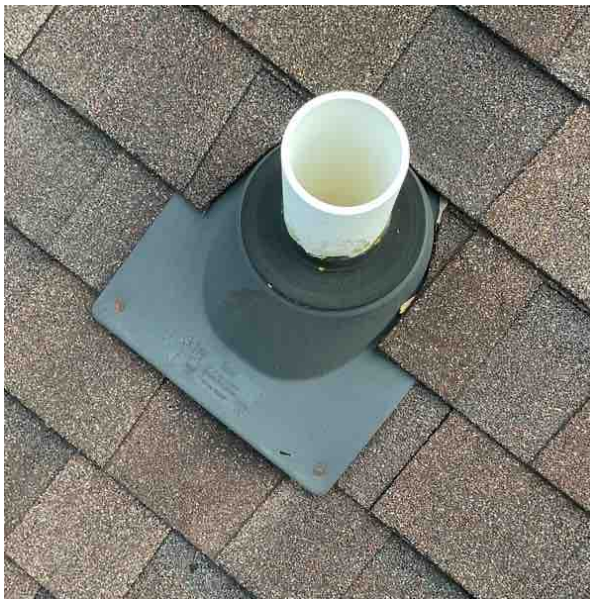
4.5.2 The caulking at the flashing nail heads was cracked, missing or deteriorated. This can cause water to penetrate through the flashing and potentially cause water damage to the underlying structure. It is recommended that a qualified roofing contractor correct the flashing is properly sealed to prevent potential water damage to the underlying structure.

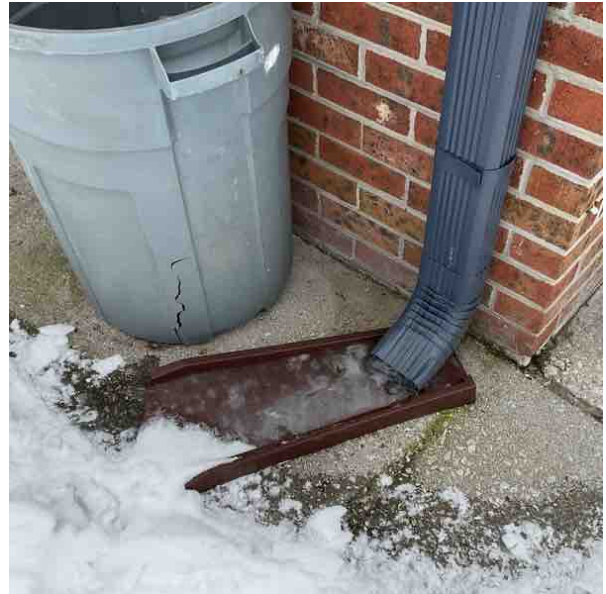
- Exterior Back
- Exterior Right

4.6.2 The downspout discharge was near the foundation. Recommend extending the downspouts approximately six to ten (6' - 10') feet away from foundation, in order to reduce risk of moisture intrusion, foundation damage and/or landscape erosion.

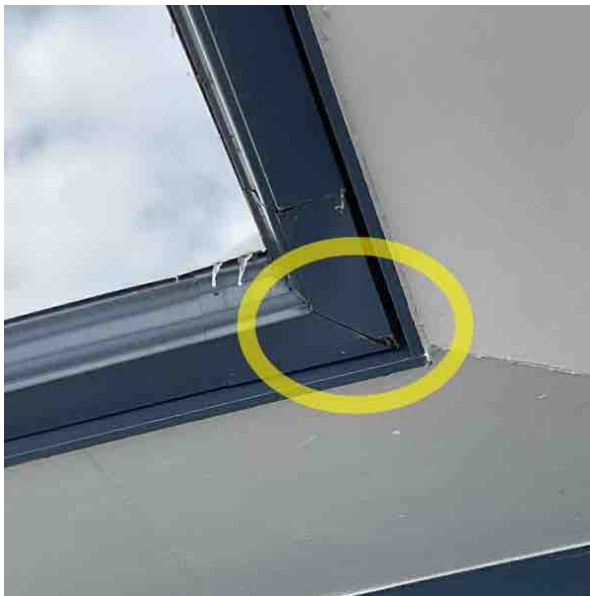
4.6.3 The gutters was leaking at the corner. Recommend correction by a qualified contractor to restore functionality and prevent water damage. **(Exterior Front)**

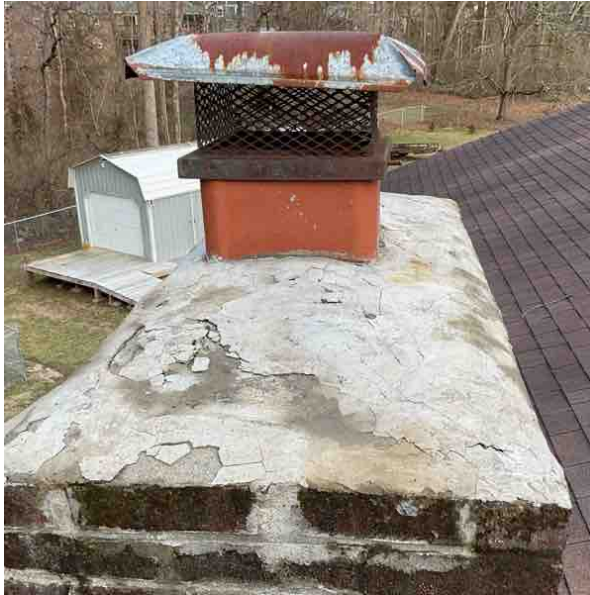
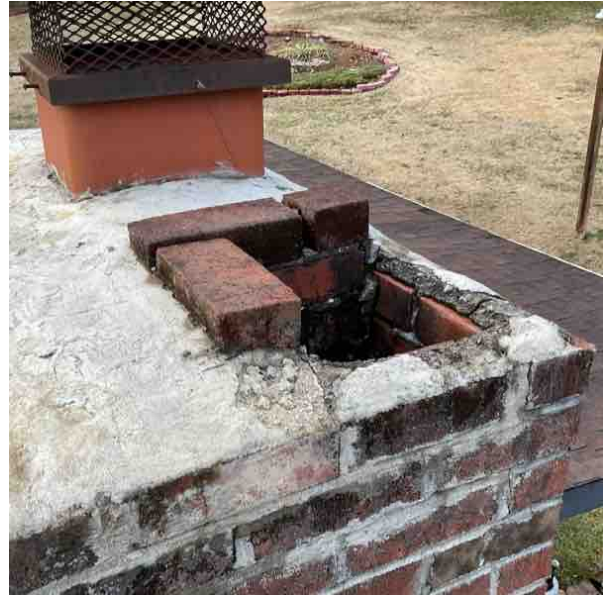
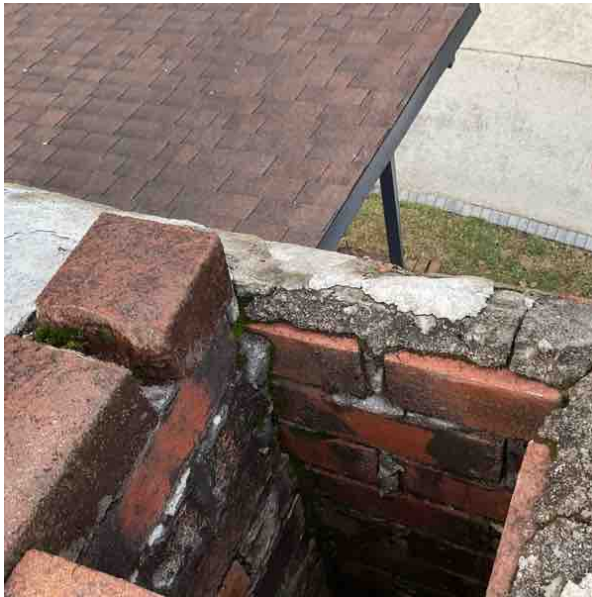
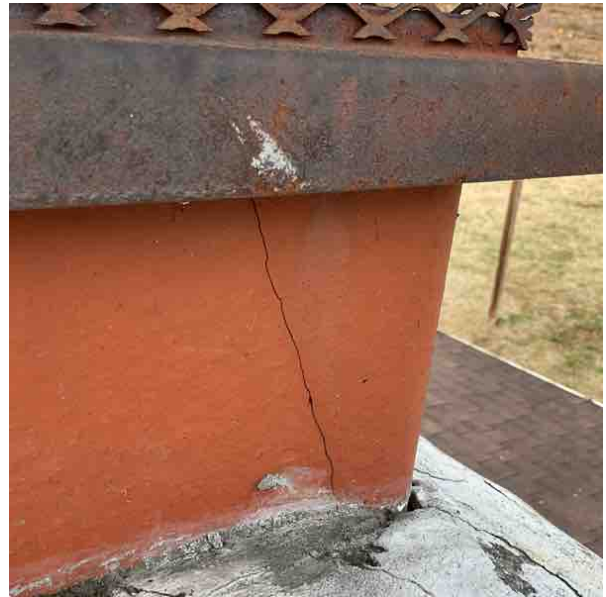
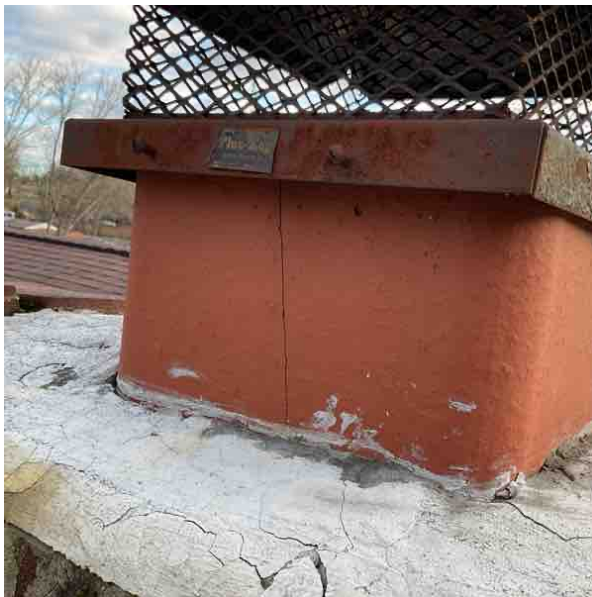
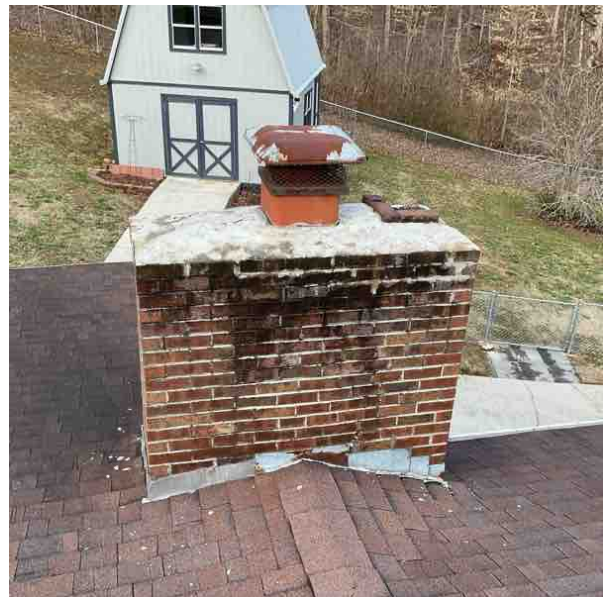
**4.7.1 There were several concerns with the chimney. A partial list of concerns includes:**

- The chimney cap was cracked, damaged, and deteriorated
- There were visibly missing bricks
- The chimney flue was cracked

**It is recommended to have a further evaluation by a qualified contractor / certified chimney sweep, to prevent any further damage.**

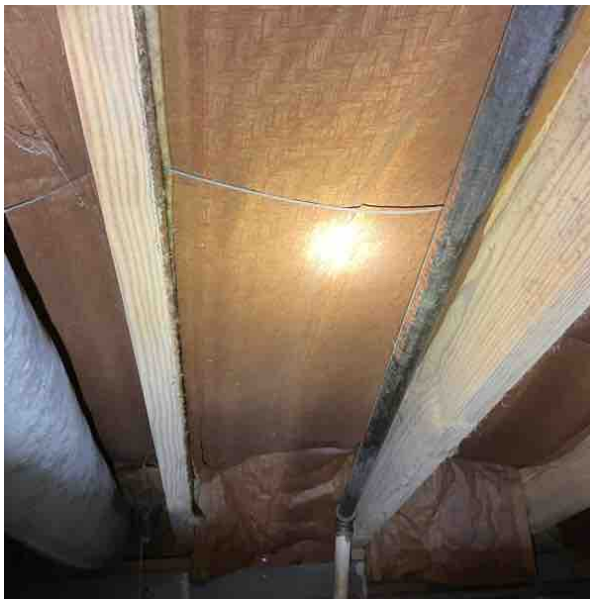
8.2.1 The insulation in the crawlspace was installed upside down. The paper backing should always face the occupied spaces. Recommend correction by a qualified contractor to restore intended functionality and reduce fire hazard. **(Crawlspace)**

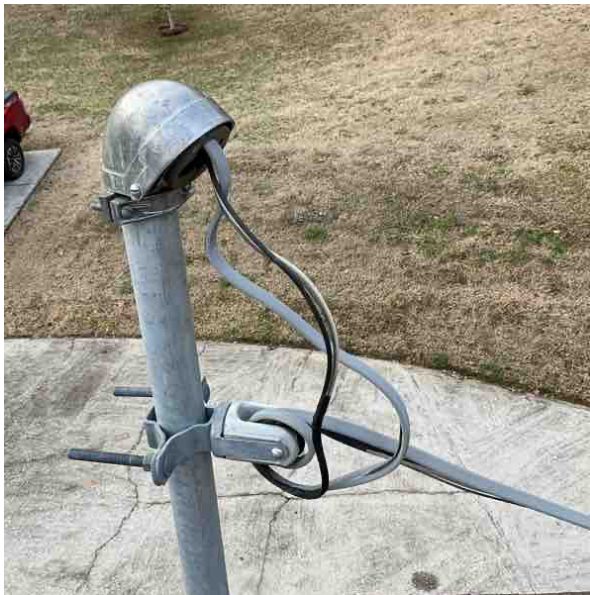
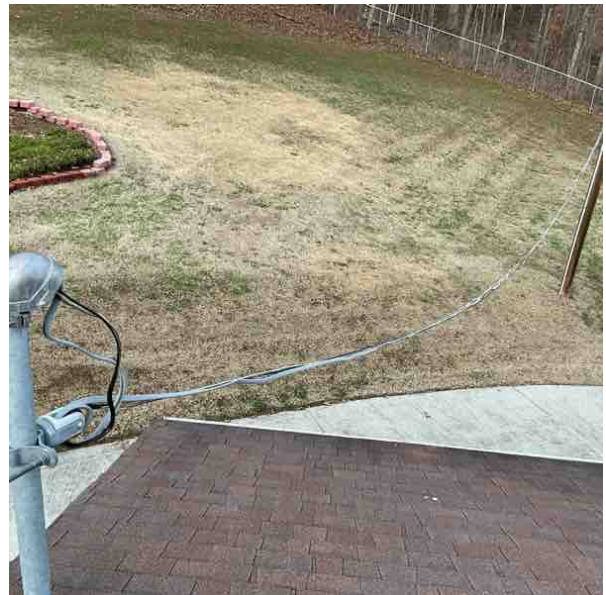
9.1.3 There was a service lateral leaving the home with missing and damaged sheathing/ insulation. This is not common and typical and may be an electrical safety hazard. It is recommended to have a further evaluation and corrections as required by a qualified electrician for electrical safety.

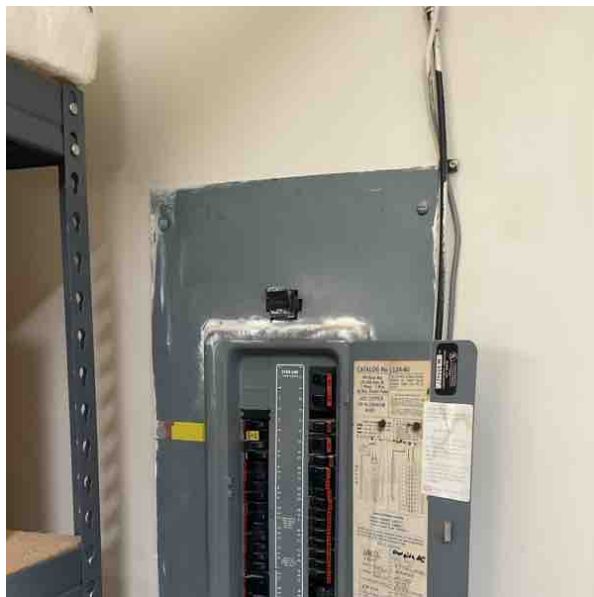
**9.5.2 The service panel was made by Federal Pacific and is the Stab-lok model. Federal Pacific Stab-lok model service panels are considered a safety hazard and should be replaced. Recommend correction by a licensed electrician for electrical safety. (Garage)**

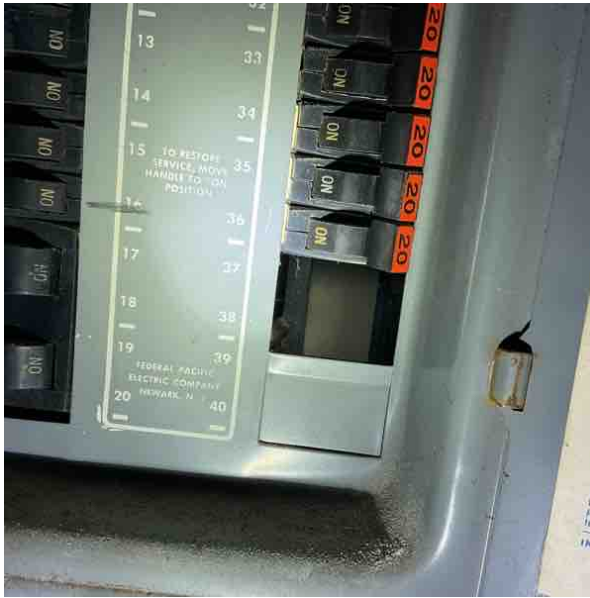
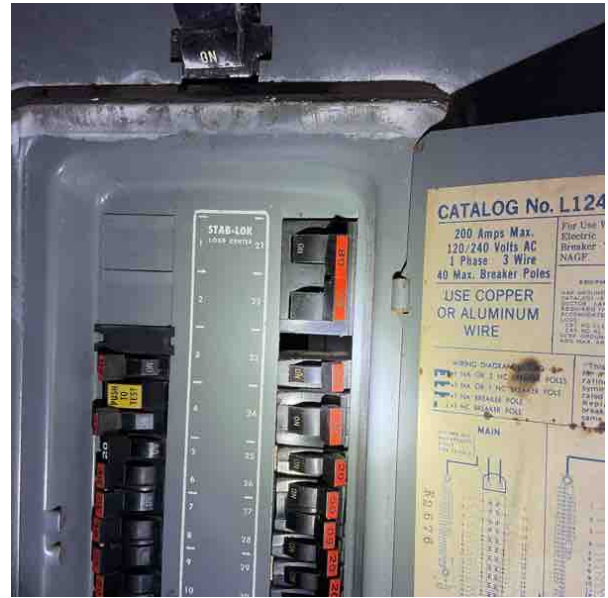
9.5.3 There were openings in the electrical panel, which is also known as knockouts or breakers missing. The openings in panels should be covered in order to prevent electrical shock. It is recommended that a licensed electrician correct the missing breakers or knockouts in the electrical panel for electrical safety. (Garage)

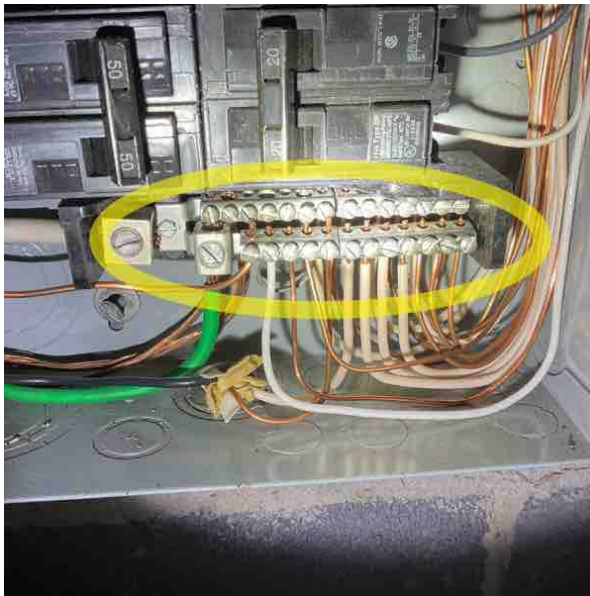
9.6.3 The neutral and ground conductors were connected in the sub-panel. This is not allowed in generally accepted electrical practices except in the service main panel. It is recommended to have a qualified electrician correct the panel wiring as required for electrical safety. (Crawlspace)

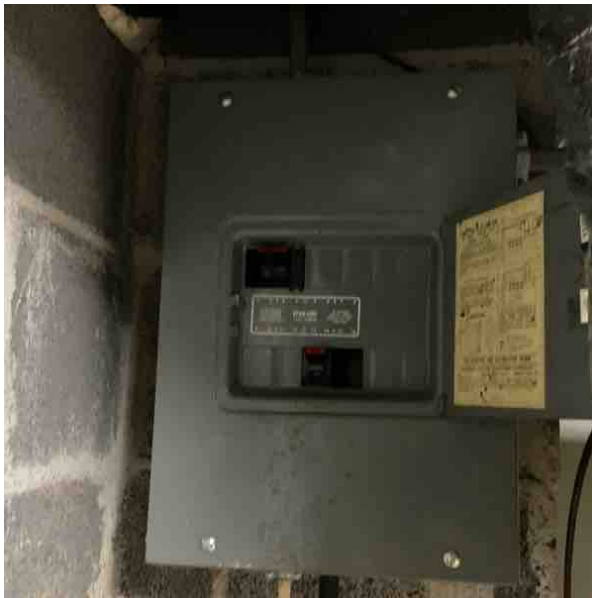
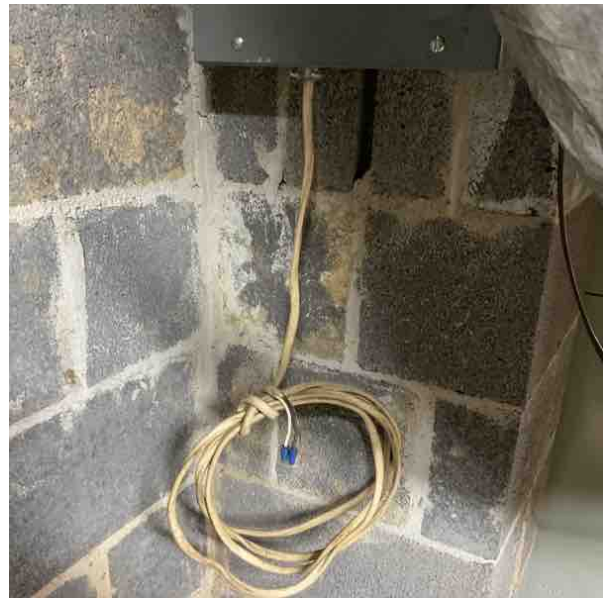
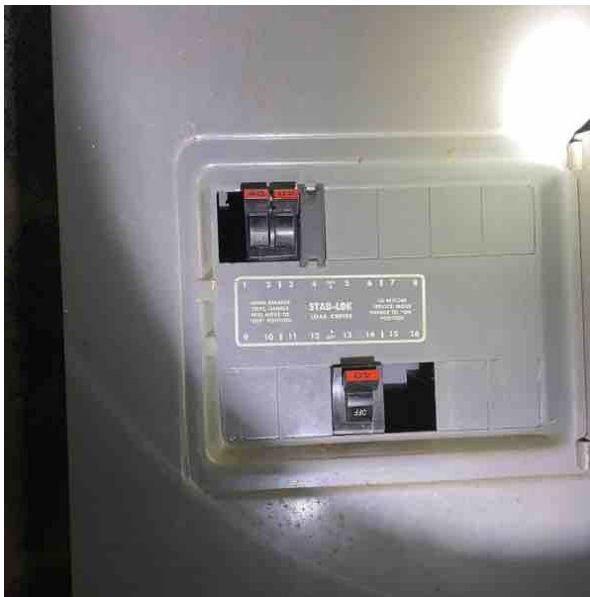
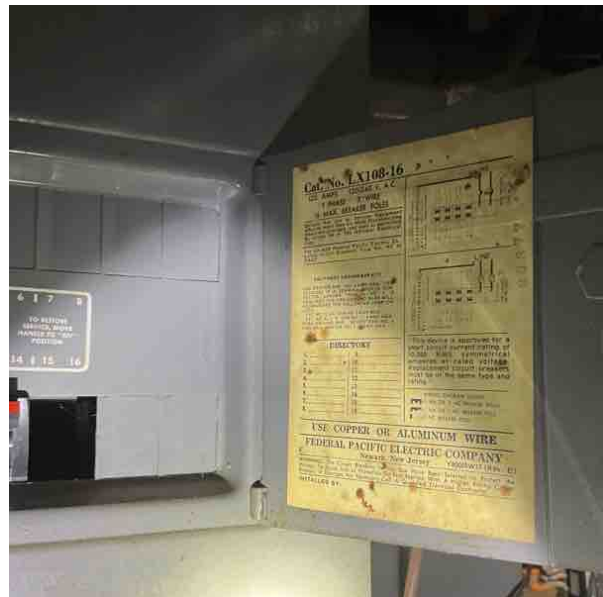
9.6.5 The subpanel was made by Federal Pacific and is the Stab-lok model. Federal Pacific Stab-lok model service panels are considered an electrical safety hazard. The panel cover was not removed due to known issues with this type of panel. Additionally, there were loose wires, and missing knockouts. This is an electrical safety hazard and it is recommended to have the panel corrected by a licensed electrician for electrical safety. **(Crawlspace)**

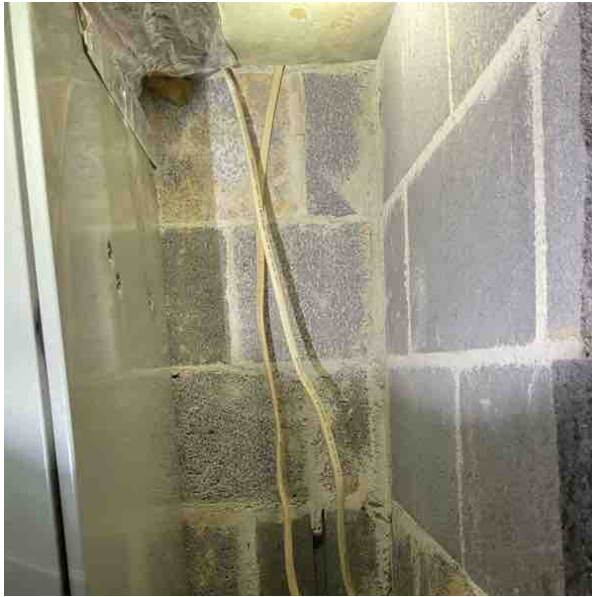
9.7.2 The branch circuit wiring is loose / not secure. A qualified electrician should correct as required for electrical safety. **(Crawlspace)**

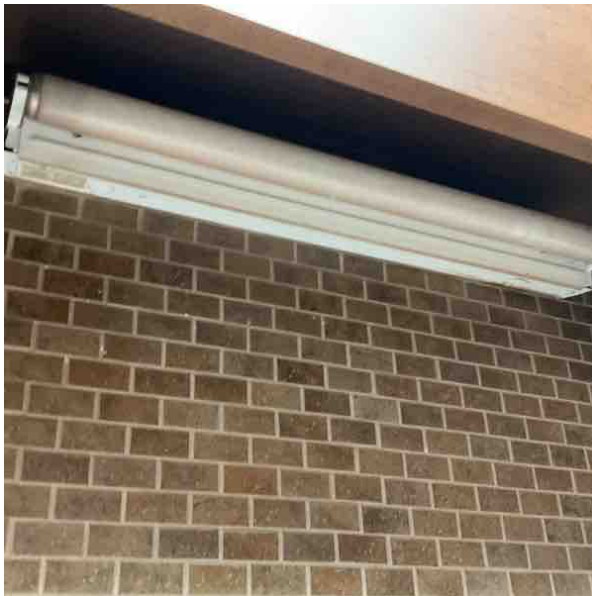
9.8.2 A ceiling light fixture did not respond to the switch. The bulb may need to be replaced or there may be a problem with the switch, wiring or light fixture. If after the bulb is replaced this light still fails to respond to the switch, this condition may represent a potential fire hazard and the Inspector recommends that an evaluation and any necessary repairs be performed by a qualified electrical contractor. **(Kitchen)**

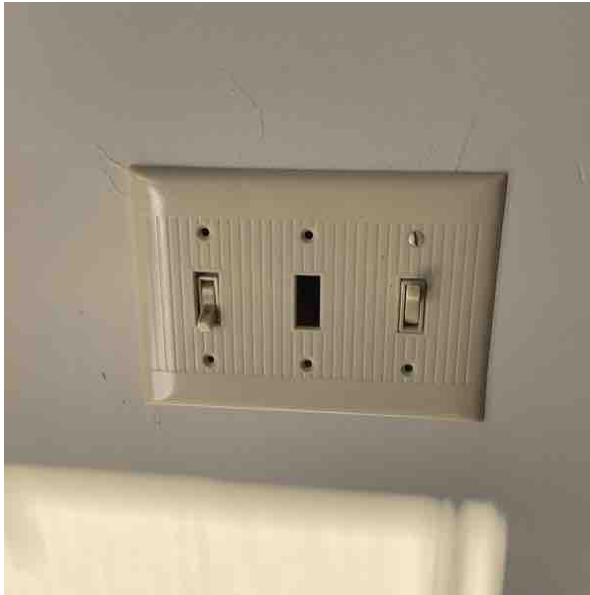
9.8.3 The cover plate was the wrong type and had a missing switch. It is recommended to replace the cover as needed. **(Entryway)**

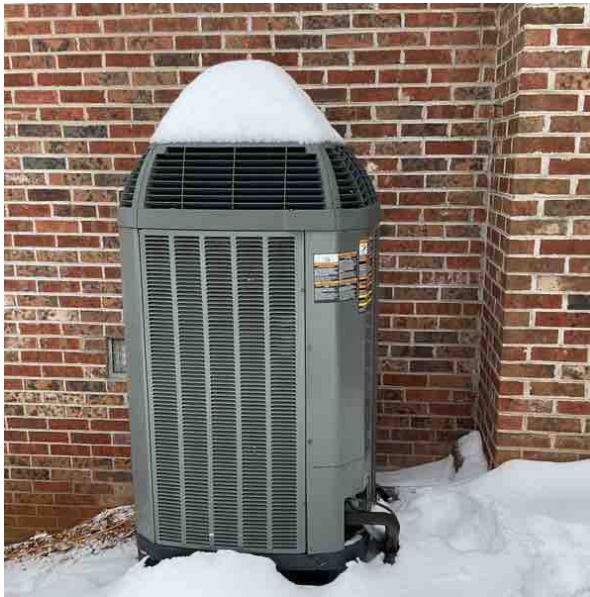
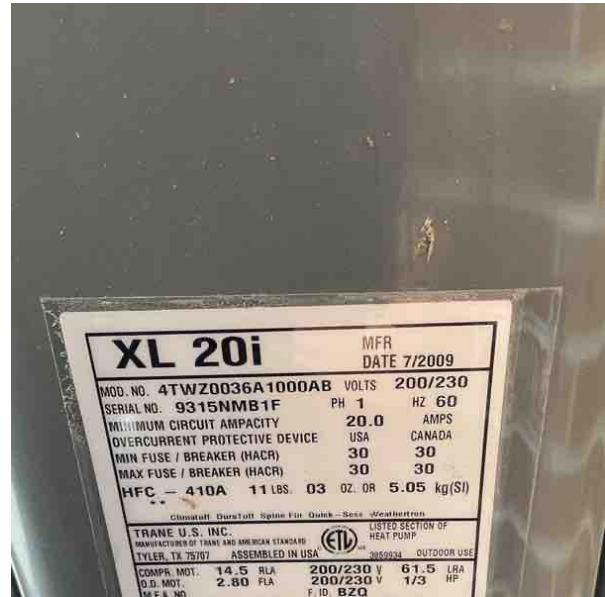
**10.6.6 The HVAC system was 15 years old. The life expectancy for similar units is 15 years. Although it is impossible to determine when a HVAC system may fail, due to the age of the system and current condition of unit, it is recommended to have a further evaluation, service, and cleaning by a qualified HVAC contractor. If a recent service has been provided, it is recommended to obtain a copy of the service work order. Recommend maintaining a maintenance service agreement for ongoing repair costs, and to consider obtaining a home warranty covering HVAC systems. (Exterior Back)**

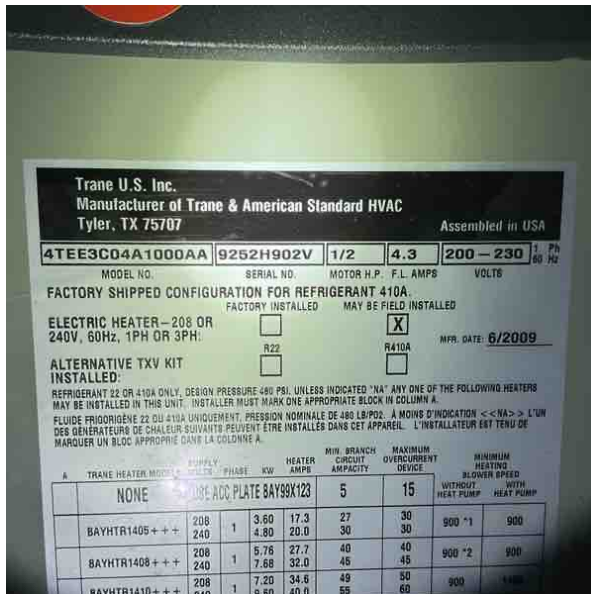
**10.6.7 The HVAC system was 15 years old. The life expectancy for similar units is 15 years. Although it is impossible to determine when a HVAC system may fail, due to the age of the system and current condition of unit, it is recommended to have a further evaluation, service, and cleaning by a qualified HVAC contractor. If a recent service has been provided, it is recommended to obtain a copy of the service work order. Recommend maintaining a maintenance service agreement for ongoing repair costs, and to consider obtaining a home warranty covering HVAC systems. (Crawlspace)**

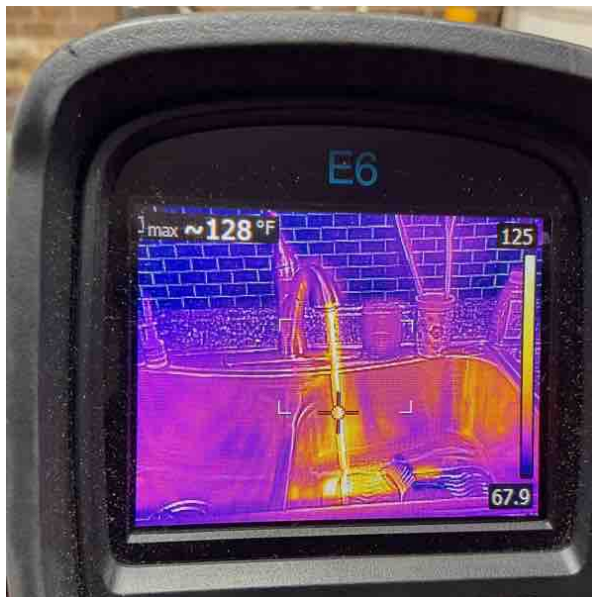
11.5.3 **The water temperature was too high. There is a risk of scalding when the temperature is higher than 120F. Recommend correction/ adjusting the water temperature by a licensed plumber for safety.**

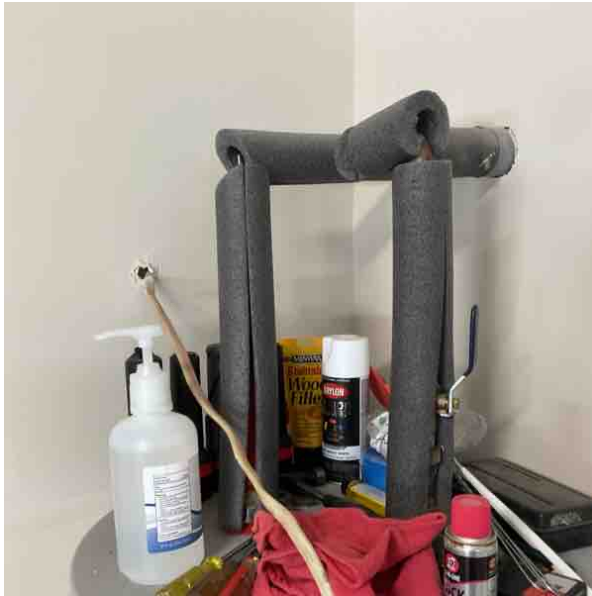
11.5.4 The PEX piping at the water heater did not have proper clearances from the water heater. PEX must be kept at least 18 inches away from the top of a water heater. Recommend correction by a qualified plumber to prevent water related damage to interior surfaces. **(Garage)**

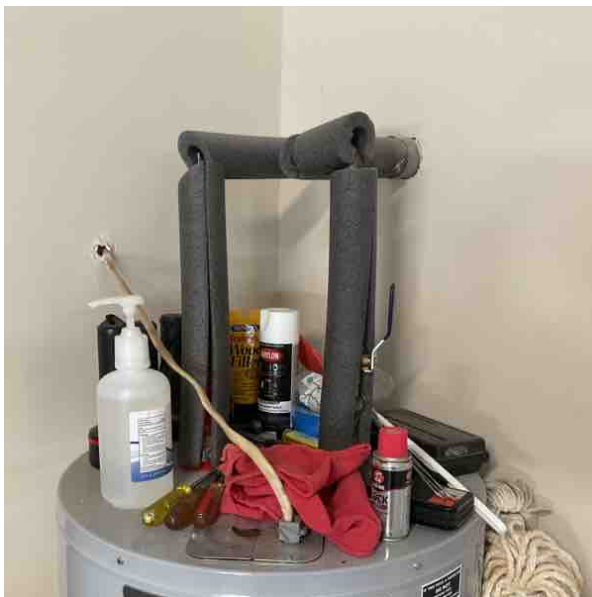
11.5.5 The water heater did not have a thermal expansion tank. This configuration does not offer the interior plumbing fixtures protection from thermal expansion. Installation of a thermal expansion tank is now required when replacing the water heater. Recommend installation of an expansion tank by a licensed plumber. **(Garage)**

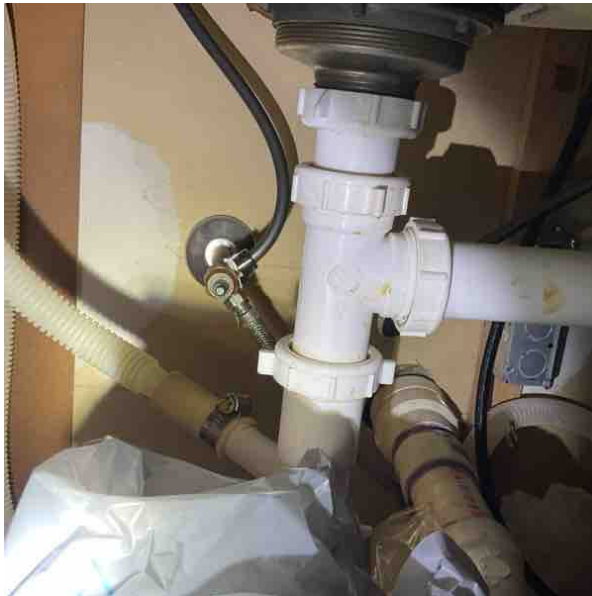
11.7.2 **The hot water valve handle was missing. Recommend correction by a licensed plumber to restore functionality. (Kitchen)**

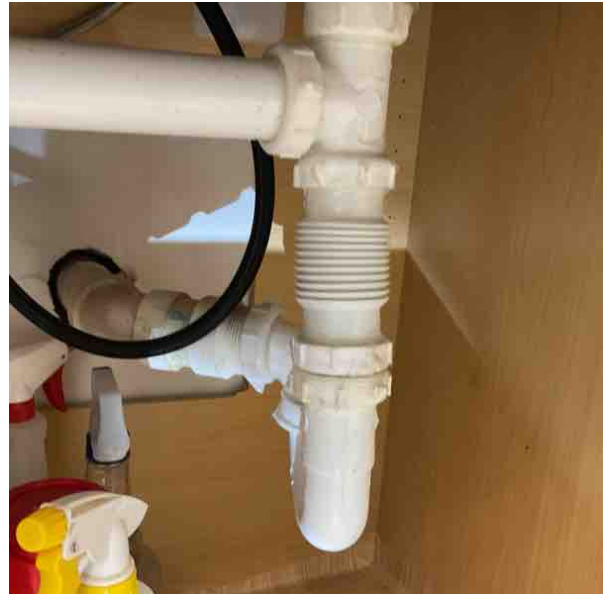
- Basement Kitchen
- Hallway Bathroom

11.7.3 The sink drain pipe has a flexible section. These are more prone to leaks, clogging and slow drains than standard smooth piping. The trap was functional. Recommend monitoring for slow drains and correction as needed by a licensed plumbing contractor.

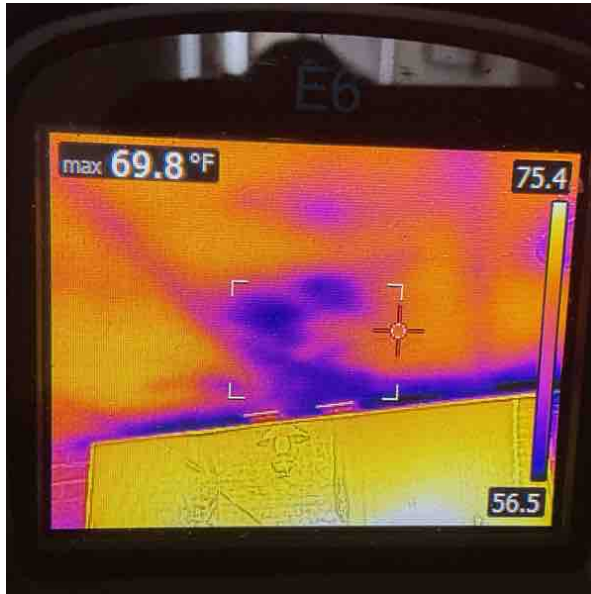
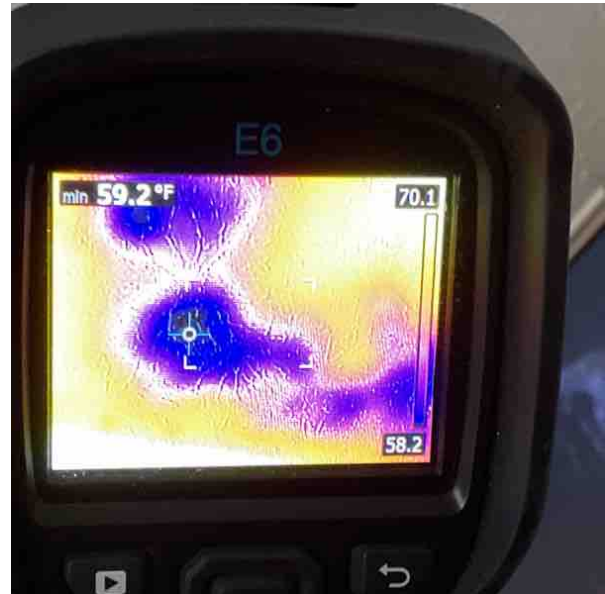
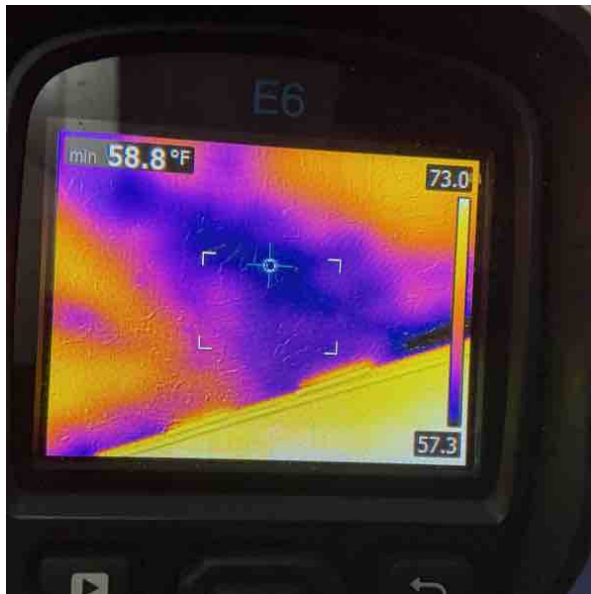
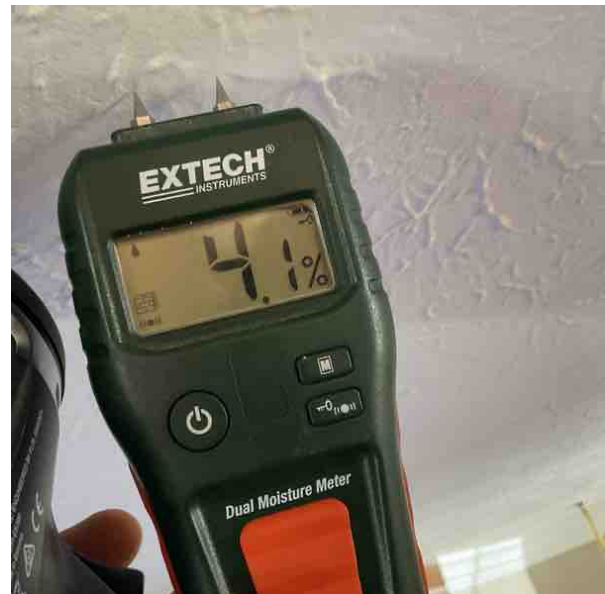
12.2.3 There was indications of a thermal anomaly on the ceiling. The cooler sections of the ceiling were scanned with a moisture meter and measured dry during the inspection. It is recommended to have a further evaluation by a qualified contractor to determine whether repairs are required to prevent water damage. **(den)**

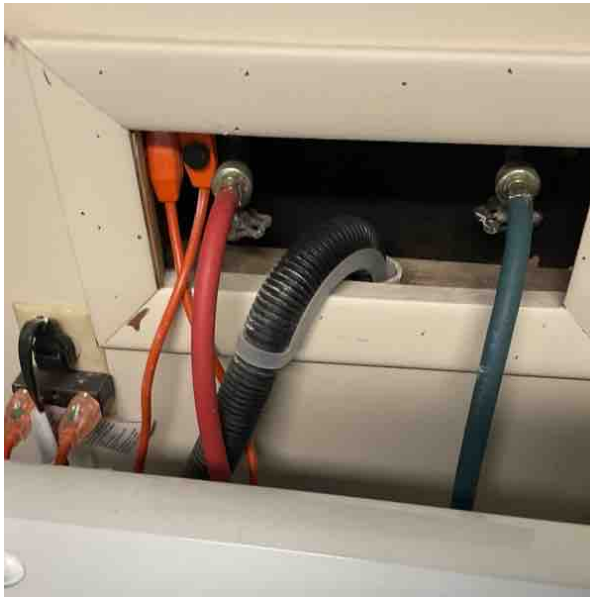
14.7.2 Recommend installing stainless steel braided hoses due to its higher resistance to bursting. **(Garage)**
