## Home Inspection Report

PROPERTY INSPECTED:  
**5916 Meadow Oaks Lane**  
**Knoxville, TN 37920**

**Date of Inspection: 01/18/2024**

Inspection No. 351436-1291

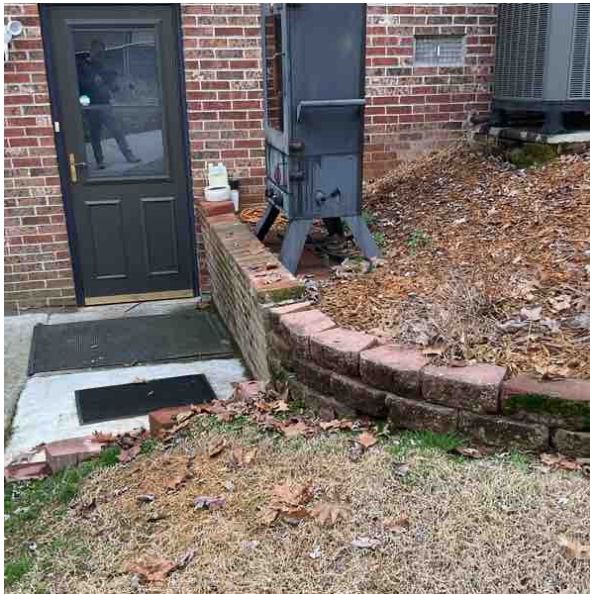
2.3.2 The retaining wall is leaning. No improvement / repair is required at this time. Monitor for damage / further deterioration as conditions can change over time. **(Exterior Back)**

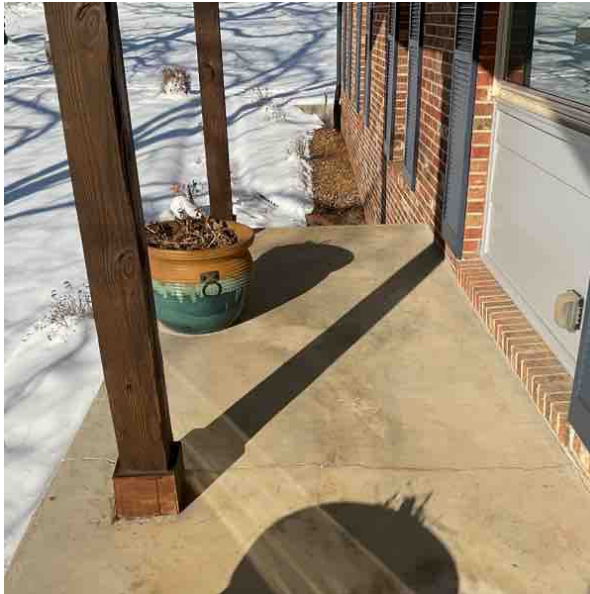
- Exterior Back
- Exterior Front

**3.7.2 The drop off height of the porch exceeded 30" with no installed guards. This is a fall safety hazard especially for children and those with reduced mobility. It is recommended to have guardrails installed where required by a qualified contractor for the safety of occupants and guests.**

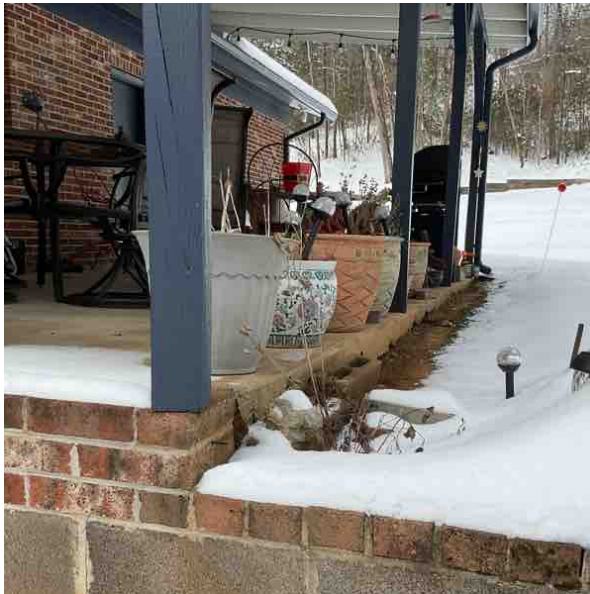
**3.7.4 The porch roof posts were not attached at the bottom. This condition has allowed one of the posts to rotate and may develop into unsafe conditions. It is recommended to have a further evaluation and corrections as needed by a qualified contractor to prevent any possible damage. (Exterior Back)**

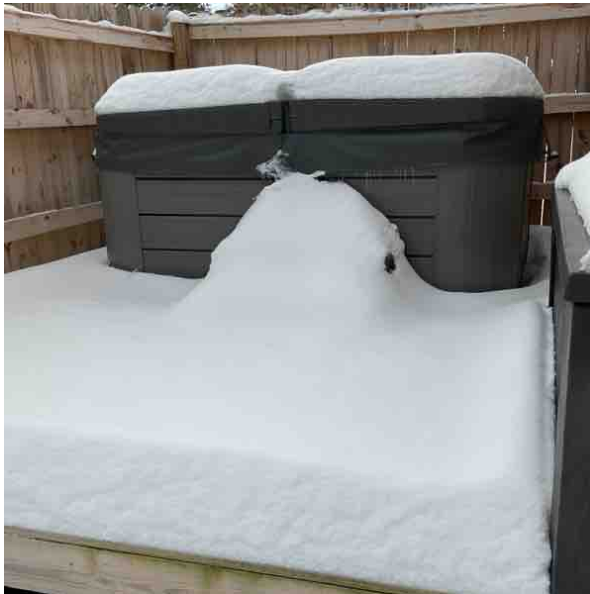
**3.8.1 The construction of the deck did not meet current industry standards. A partial list of concerns includes:**

- There were dry stacked blocks used as posts.
- The stair riser connectors were connected with deck screws.

It is recommended to have a further evaluation and corrections as needed by a qualified contractor for the safety of occupants and guests. (Exterior Right)

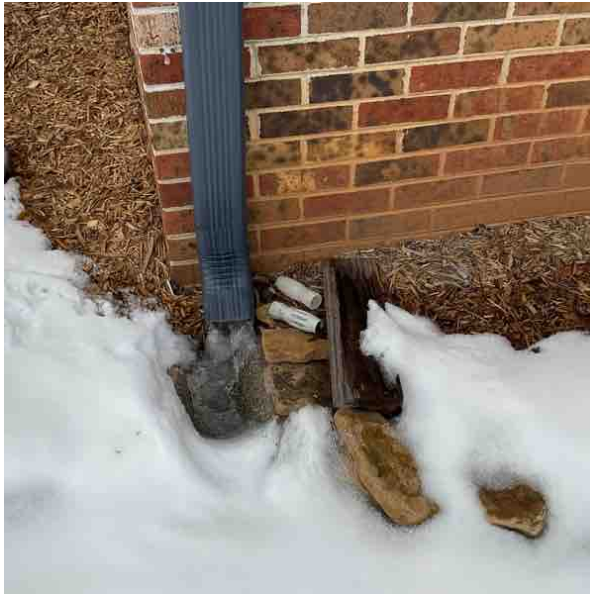
- Exterior Back
- Exterior Right

4.6.2 The downspout discharge was near the foundation. Recommend extending the downspouts approximately six to ten (6' - 10') feet away from foundation, in order to reduce risk of moisture intrusion, foundation damage and/or landscape erosion.

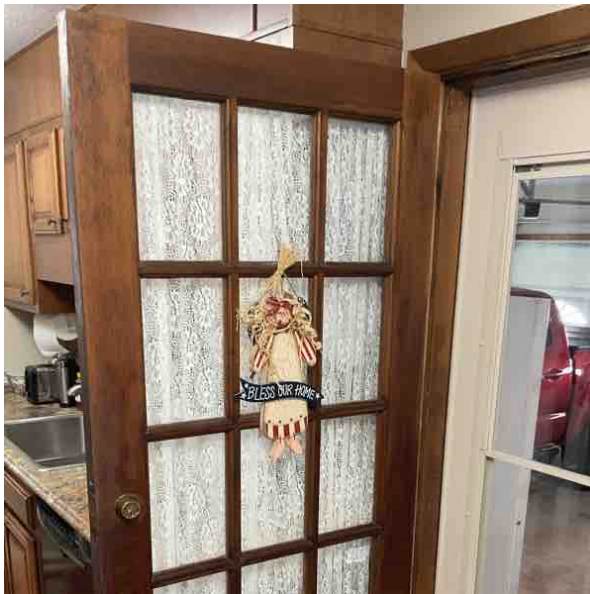
- Garage
- Kitchen

6.2.3 The door that accesses the interior from the garage was mostly glass. This did not meet the requirements of a solid wood, steel, or a 20-minute fire rated door to access the interior of the home from the garage. It is recommended to update the door as required for fire safety by a qualified contractor.

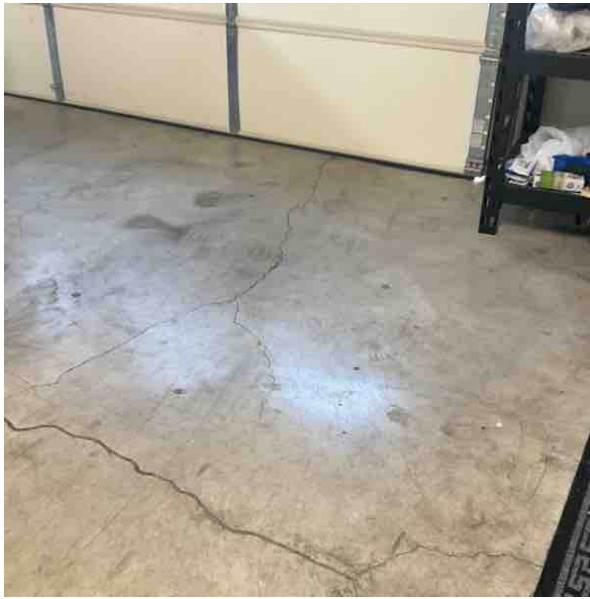
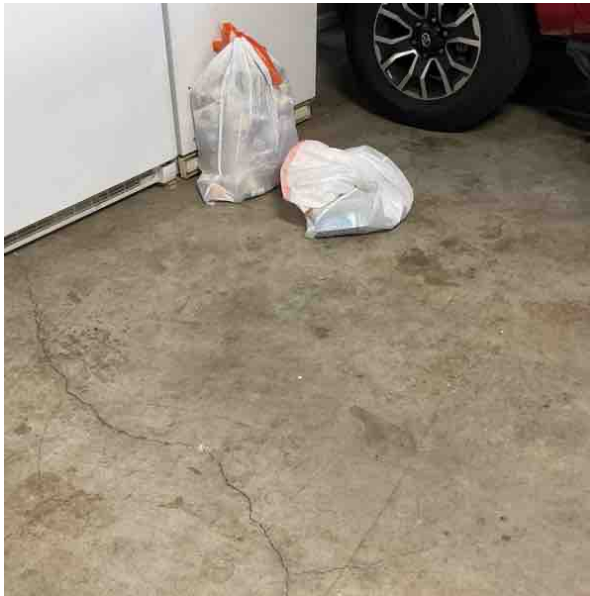
6.5.2 Example photos of garage. **(Garage)**

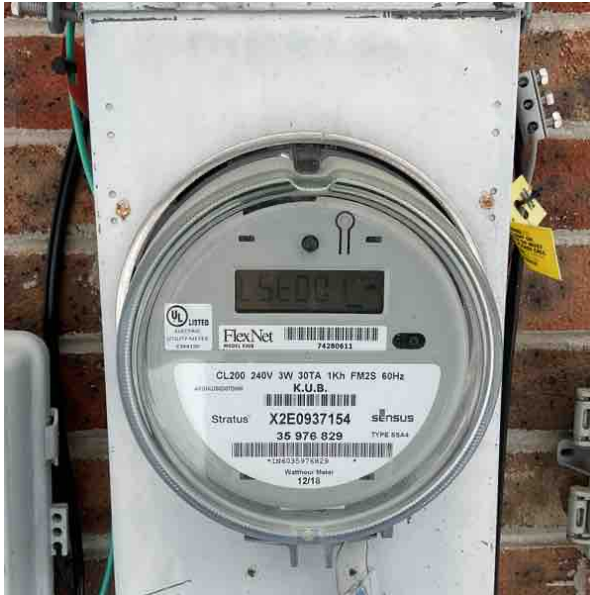
### 9.1.2 Example photo of the meter: (Exterior Left)

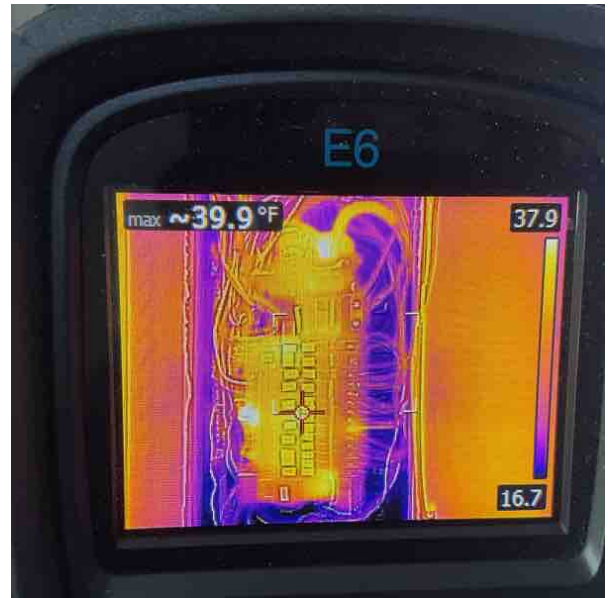
9.5.4 The distribution panel temperatures were within normal ranges. See the thermal image below. (Garage)

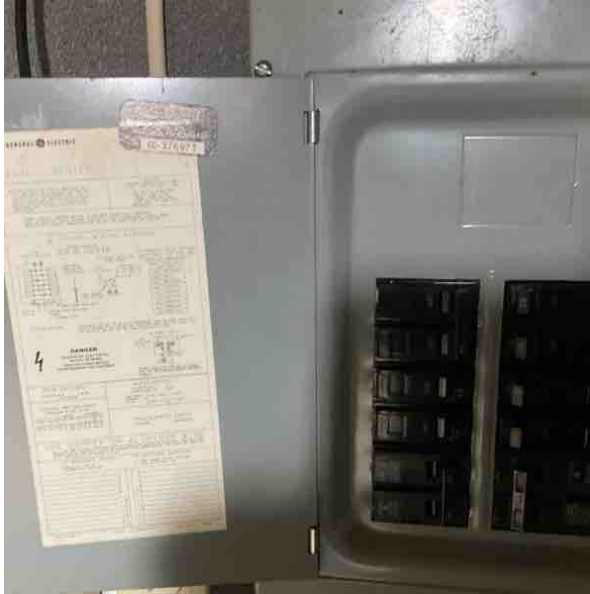
9.6.2 The individual breakers at the service panel cabinet were not labeled. The individual breakers should be labeled so that in an emergency, it can be quickly shut off. Recommend identifying the individual circuits.

**(Crawlspace)**

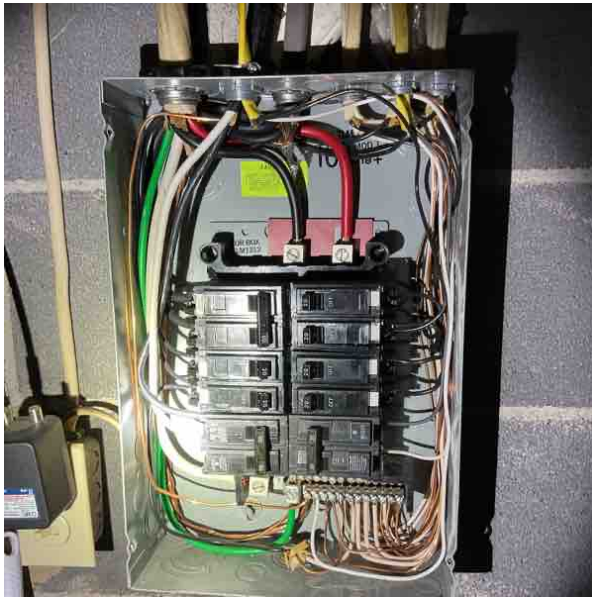
9.6.4 Example photo of sub panel with cover removed. **(Crawlspace)**

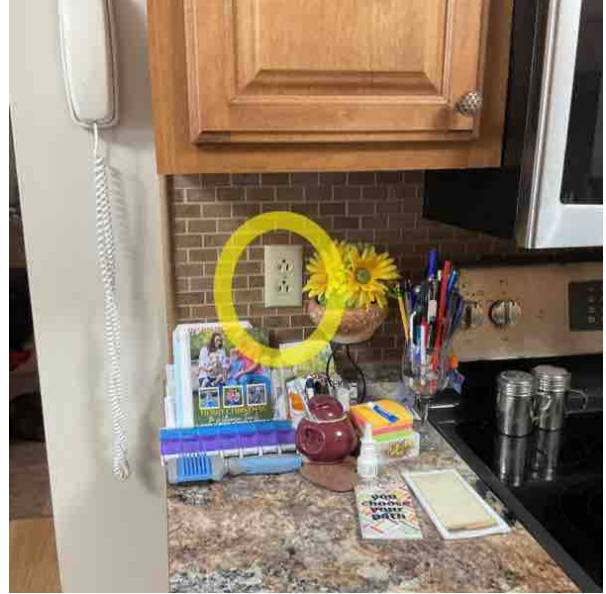
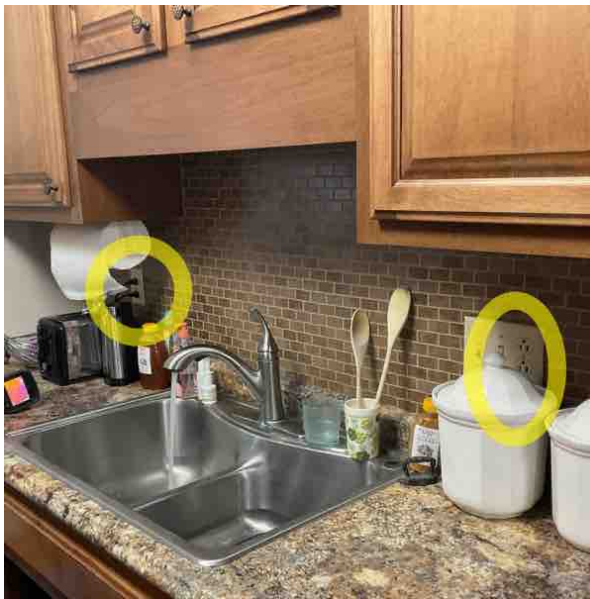
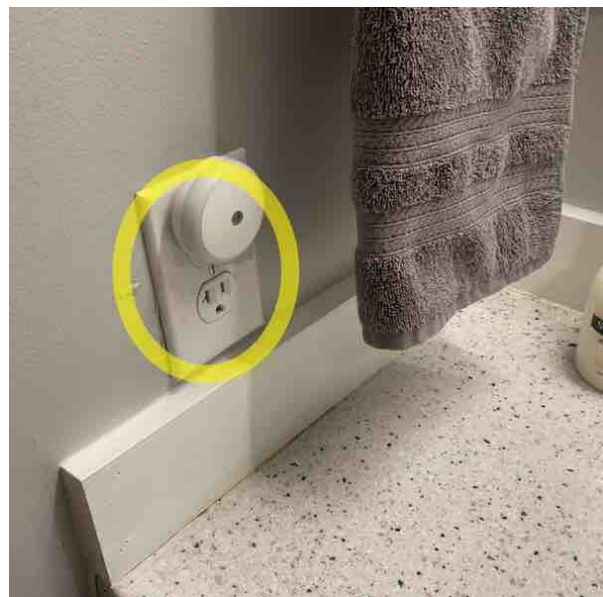
- Basement Kitchen
- Basement bathroom
- Kitchen

**9.10.3 There were electrical receptacles located in potentially damp areas, such as bathrooms, kitchens, and outdoors, that do not have Ground Fault Circuit Interrupter (GFCI) protection. GFCI receptacles are required in areas where water or moisture may come into contact with electrical devices. It is recommended that a licensed electrician upgrade these receptacles to GFCI-protected devices to ensure the safety of the property's occupants and guests.**

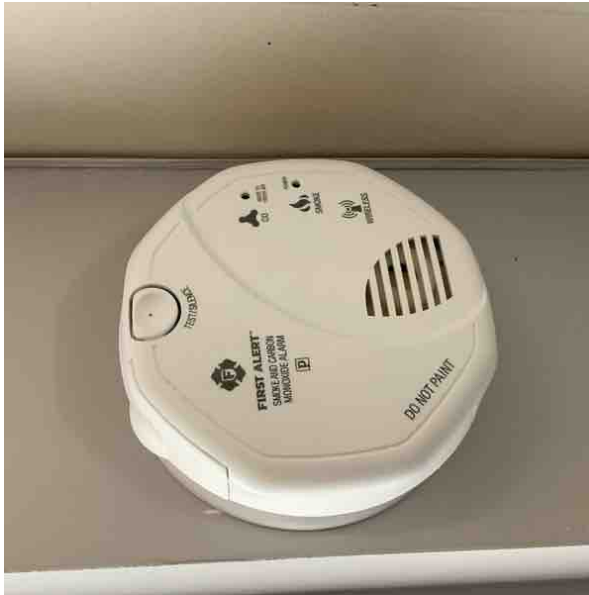
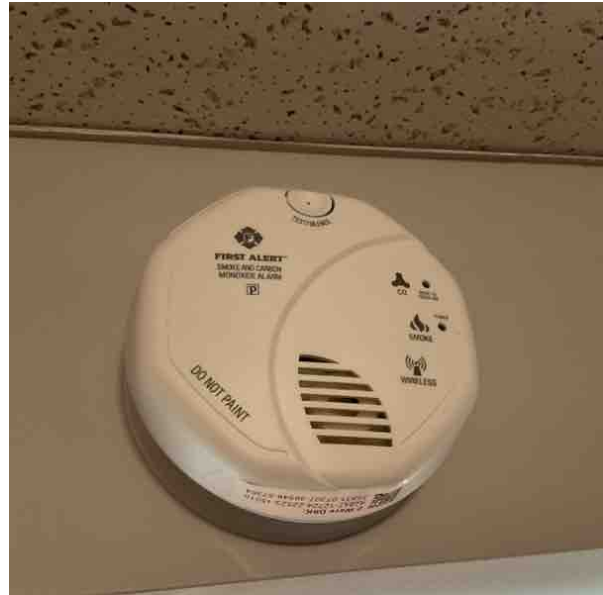
- Basement Bedroom
- Basement Family Room

9.12.1 The following rooms have an installed smoke detector:

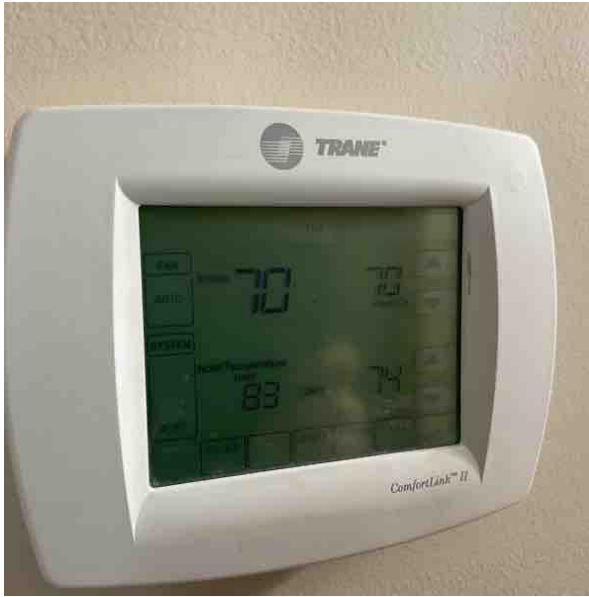
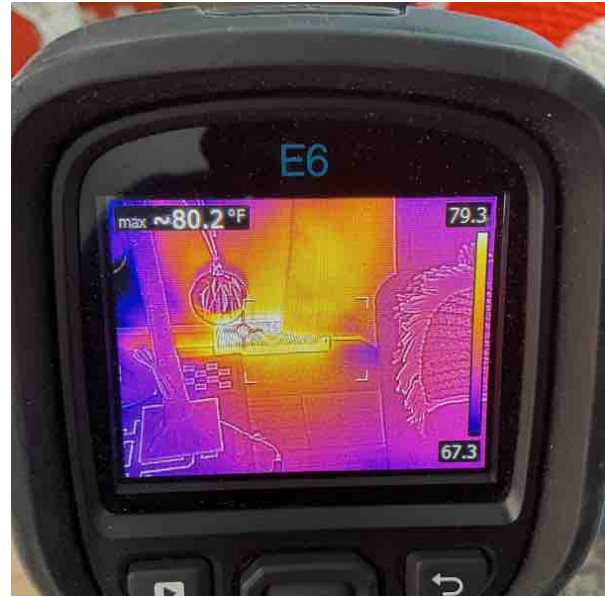
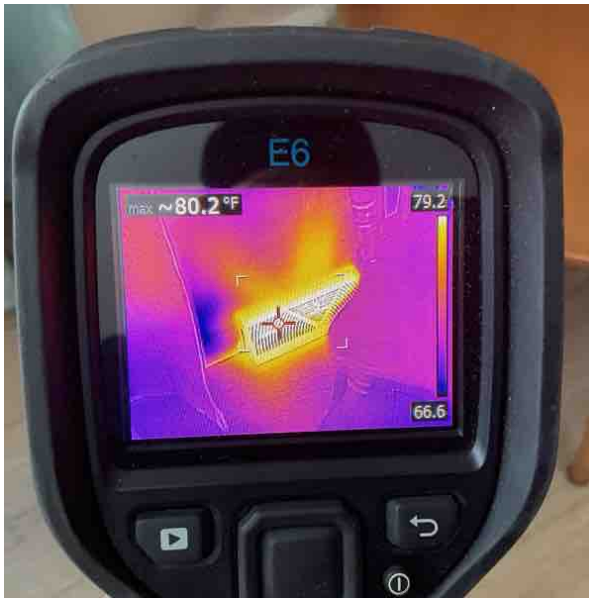
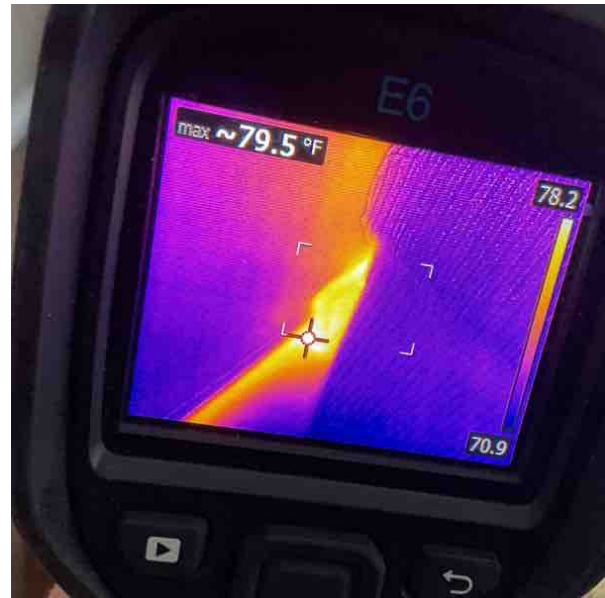
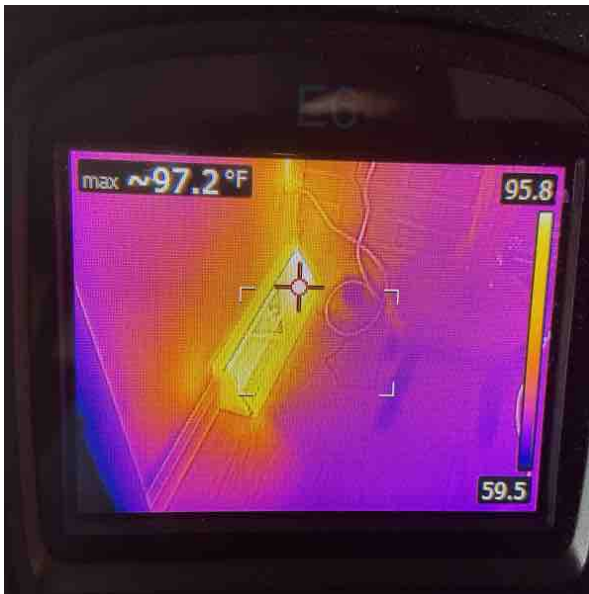
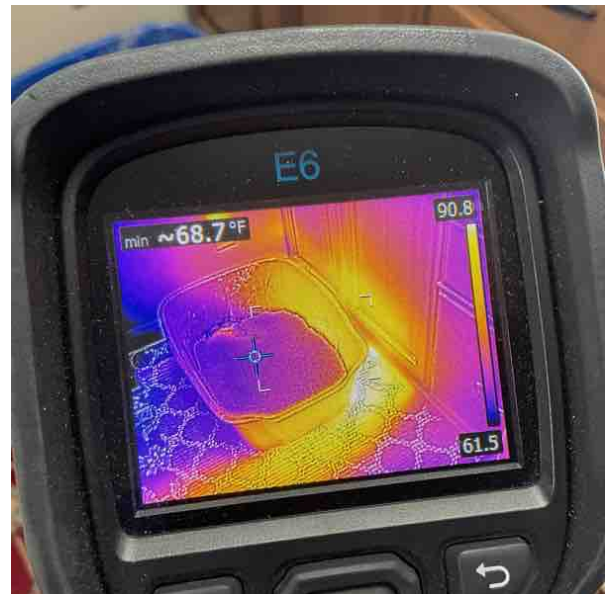
10.3.1 The thermostat was tested and was functional. See thermal images below: **(Hallway)**

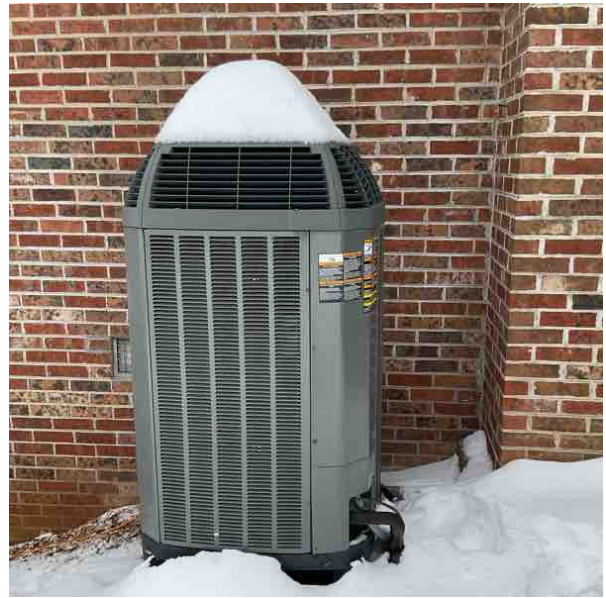
## 10.6.4 Split system electric heat pump condensing unit

- Manufacturer: Trane
- Mfg Date: 2009
- located: **(Exterior Back)**

**10.6.6 The HVAC system was 15 years old. The life expectancy for similar units is 15 years. Although it is impossible to determine when a HVAC system may fail, due to the age of the system and current condition of unit, it is recommended to have a further evaluation, service, and cleaning by a qualified HVAC contractor. If a recent service has been provided, it is recommended to obtain a copy of the service work order. Recommend maintaining a maintenance service agreement for ongoing repair costs, and to consider obtaining a home warranty covering HVAC systems. (Exterior Back)**

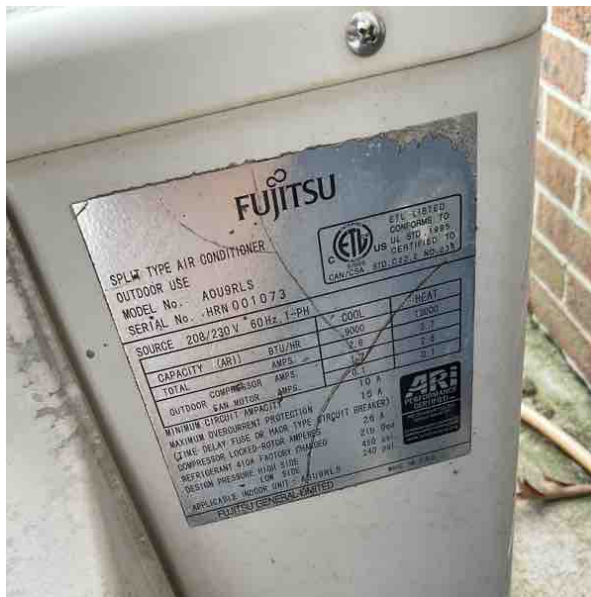
## 10.6.5 Heat pump

- Manufacturer: Fujitsu
- Mfg Date: Unknown
- located: **(Exterior Back)**

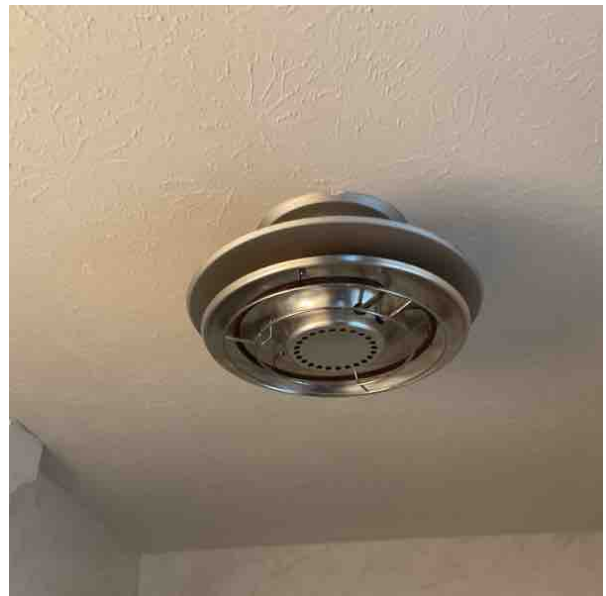
10.7.3 The bathroom heater was scanned with an infrared camera. See thermal images below. **(Primary Bathroom)**

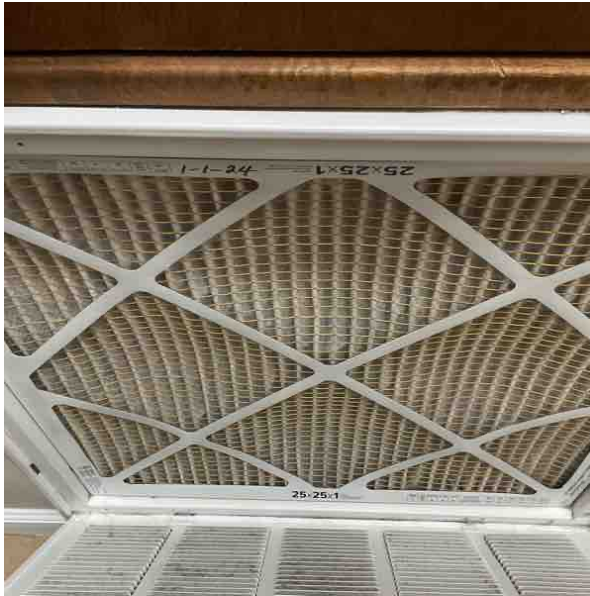
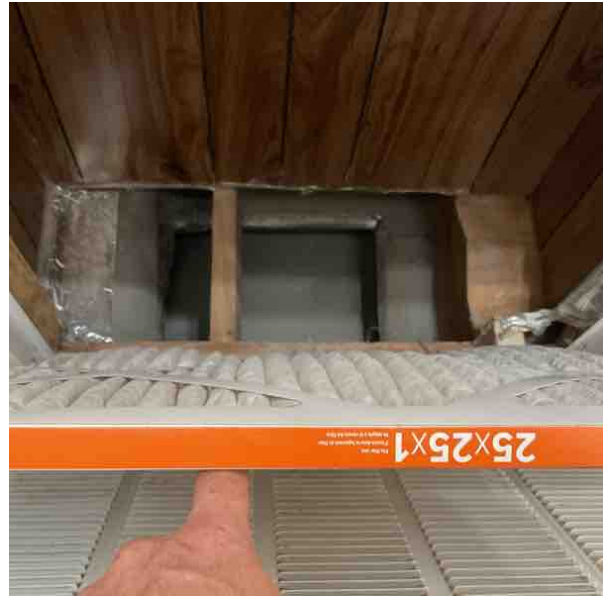
10.9.1 Recommend changing air filter approximately every 30 days or per manufacturers recommended replacement intervals. **(Hallway)**

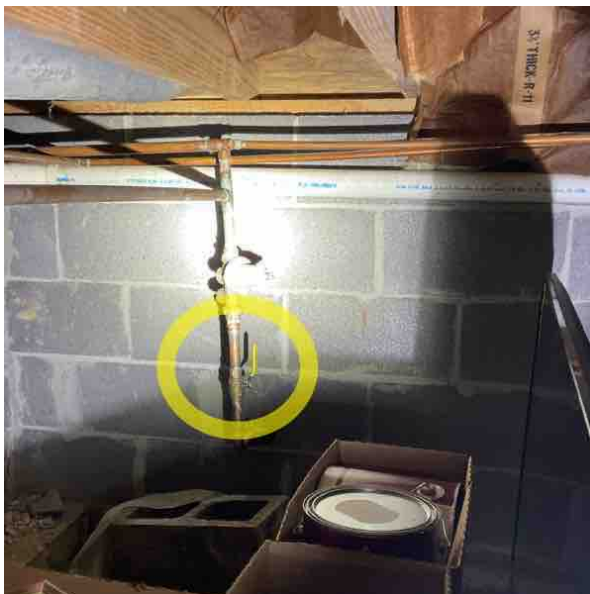
11.2.2 Main Shut Off Valve Location: **(Crawlspace)**

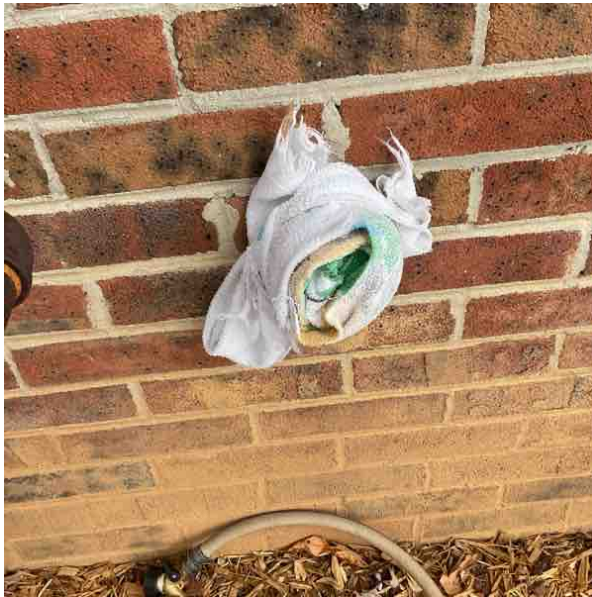
**11.6.2 Hose bib locations: (Exterior Front)**

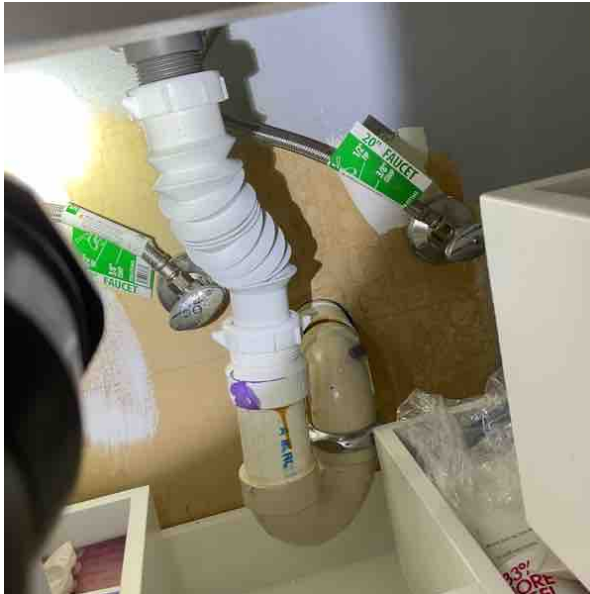
- Basement Kitchen
- Hallway Bathroom

11.7.3 The sink drain pipe has a flexible section. These are more prone to leaks, clogging and slow drains than standard smooth piping. The trap was functional. Recommend monitoring for slow drains and correction as needed by a licensed plumbing contractor.

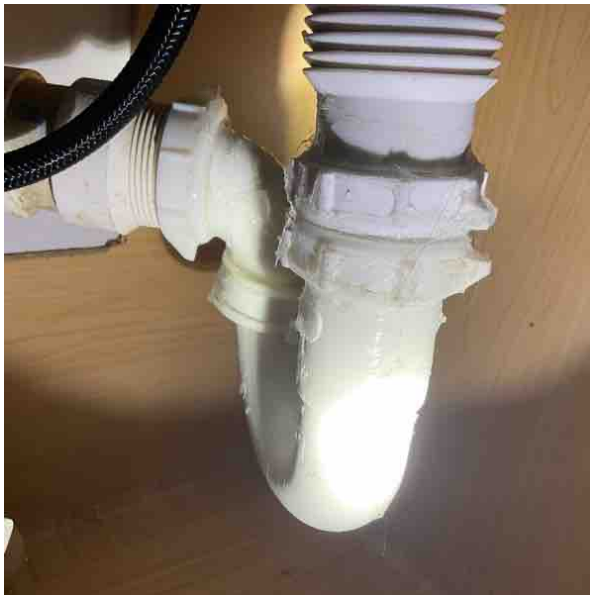
11.7.4 There was what appeared to be silicone caulk covering the trap. This is not common and typical and may be an indication of a prior leak. It is recommended to have a further evaluation and corrections as needed by a qualified plumber to prevent any possible leaks. **(Basement Kitchen)**

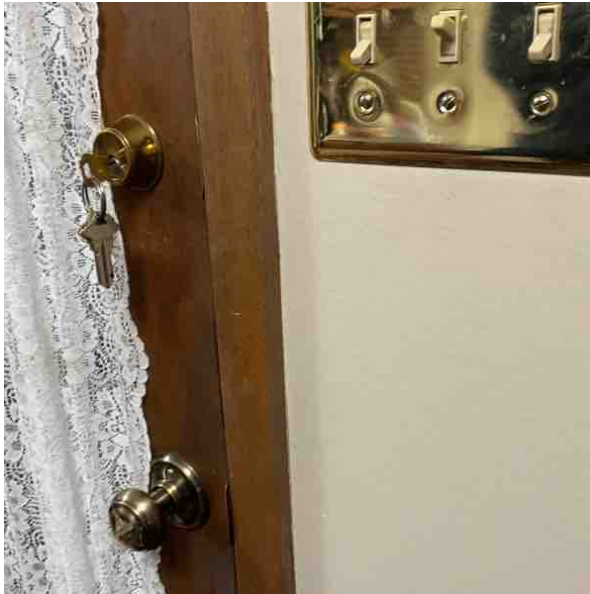
- Garage
- Kitchen

**12.3.2 The door to the garage had a deadbolt which required a key for operation from the inside. This condition is unsafe as it may slow or prevent exit during an emergency. It is recommended that all deadbolts on egress doors operate from the inside with a lever.**

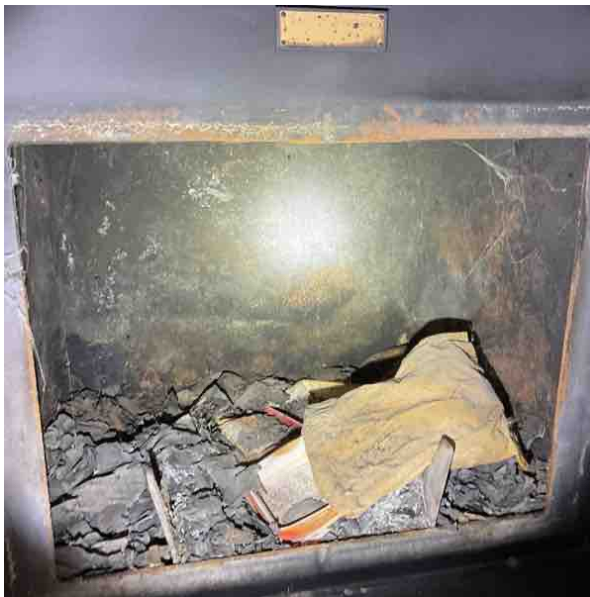
13.1.2 Fireplace-General Photos: **(den)**

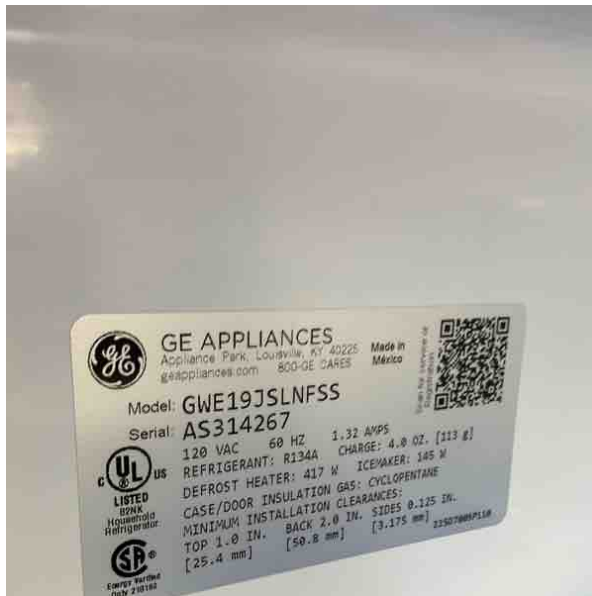
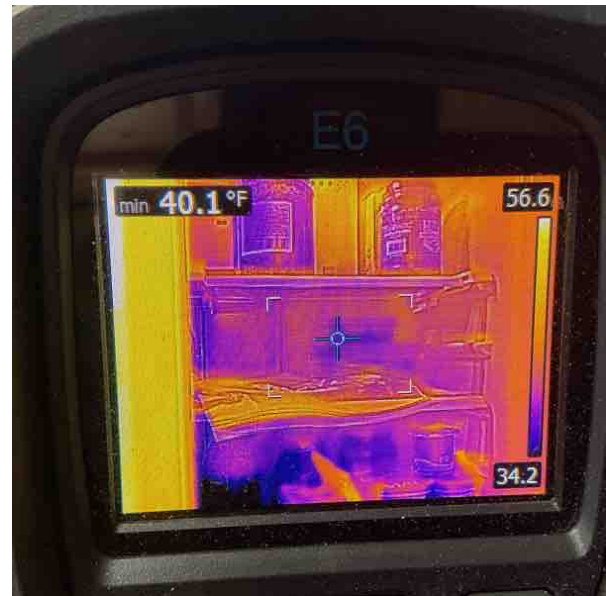
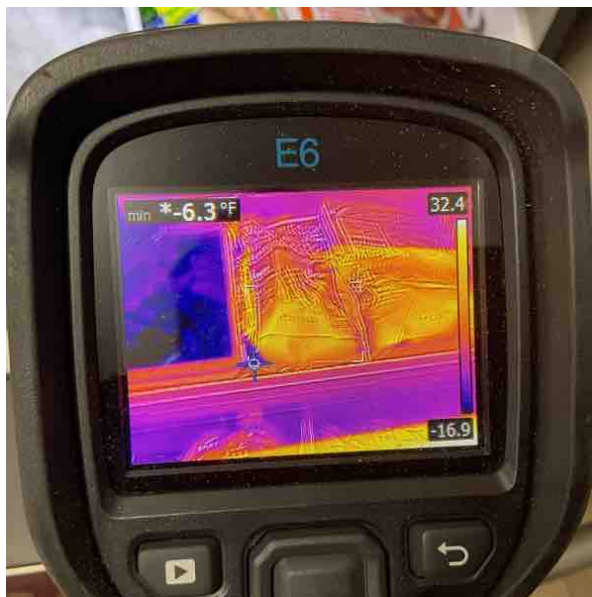
14.2.3 The refrigerator was functional. See attached thermal photos. (Kitchen)

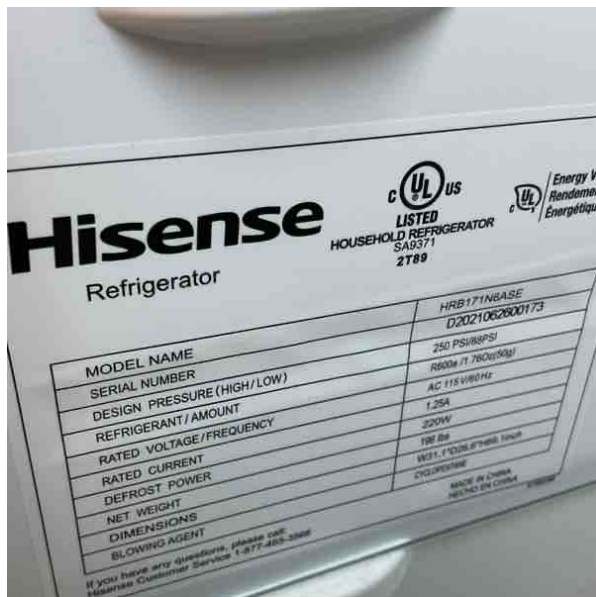
14.2.4 Example picture of fridge label plate containing model and serial number. **(Basement Kitchen)**

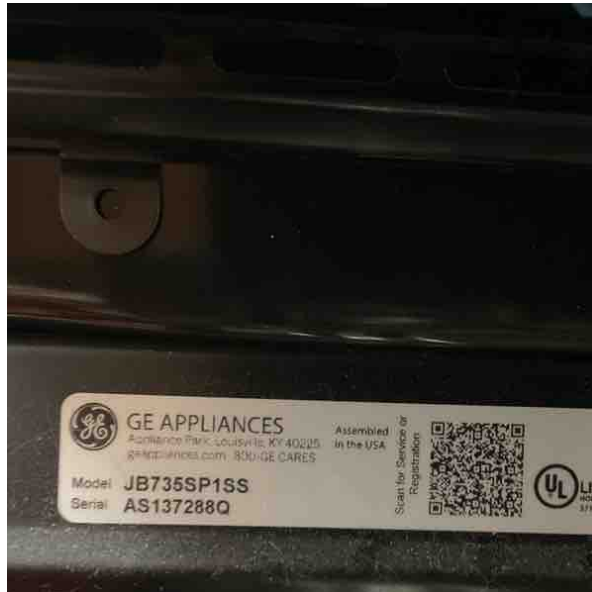
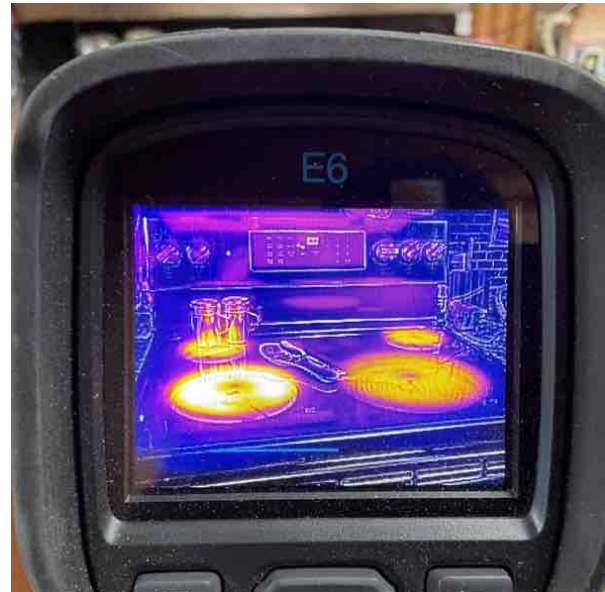
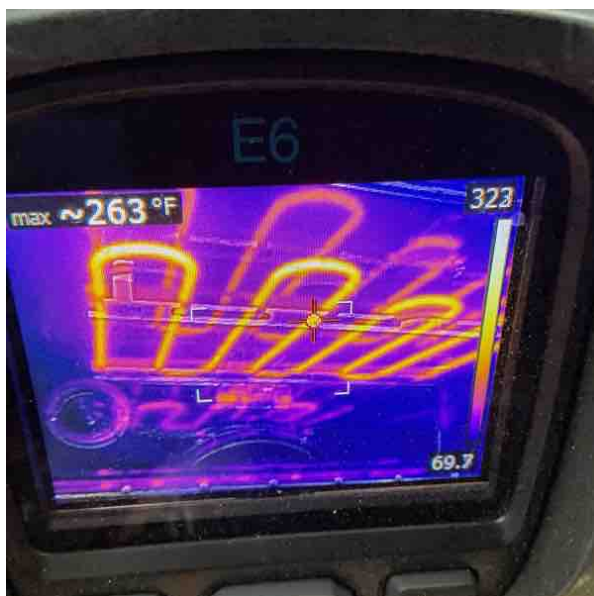
14.3.4 The range, oven, and broiler was tested and functional. See attached thermal images. **(Kitchen)**

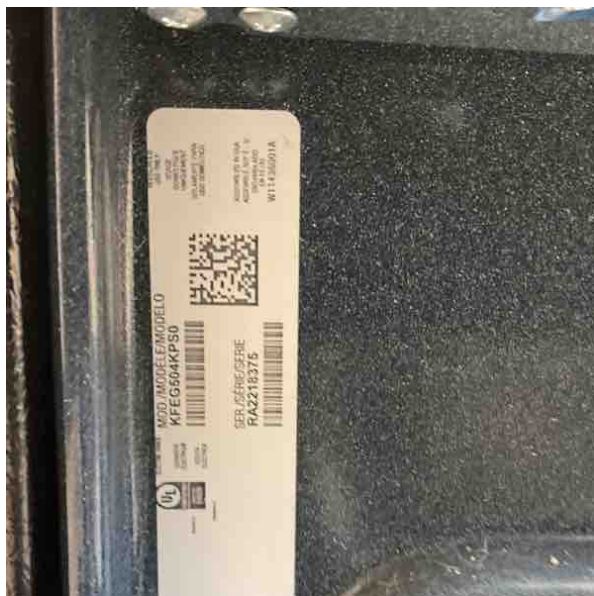
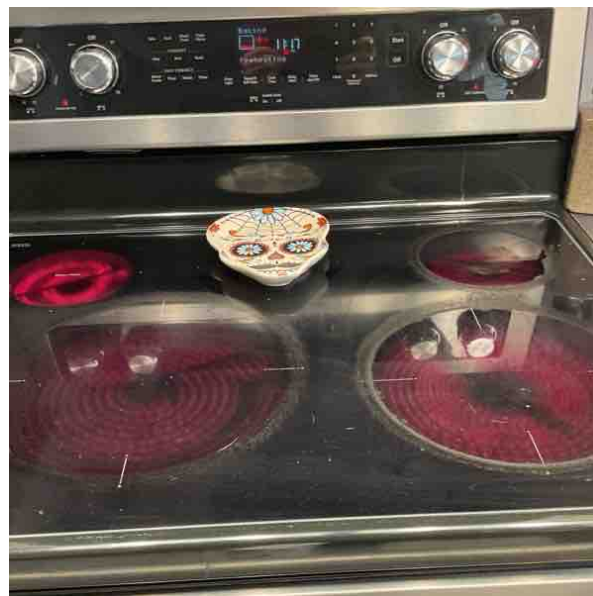
14.3.5 Example photo of range label plate containing model and serial number. **(Basement Kitchen)**

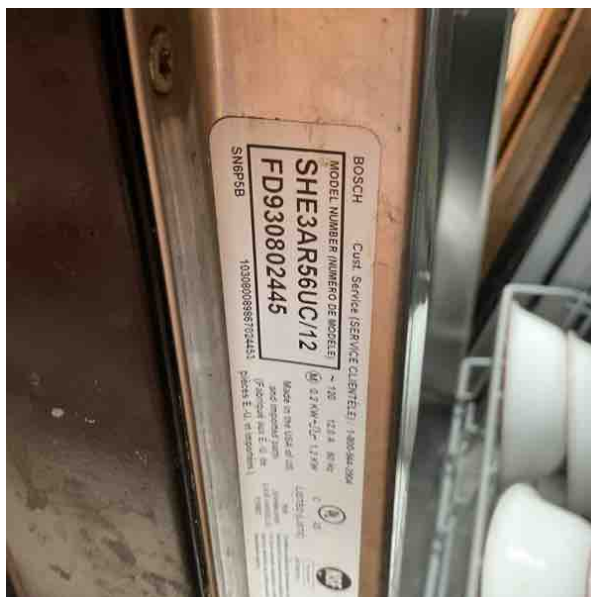
14.5.2 Example photo of dishwasher label plate containing model and serial number. **(Kitchen)**

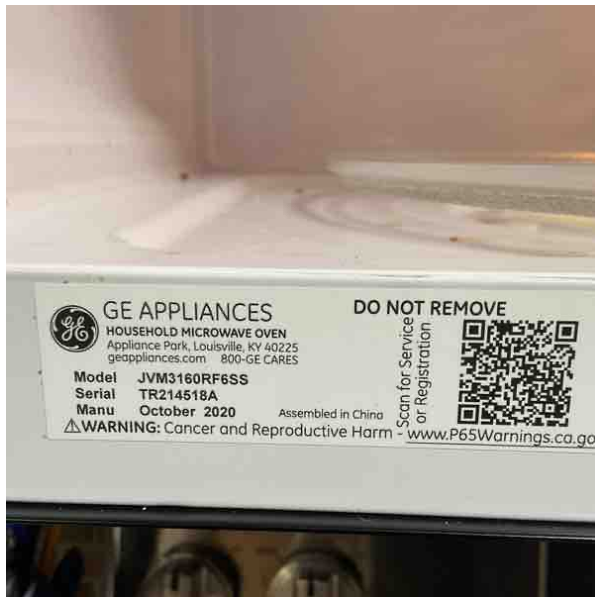
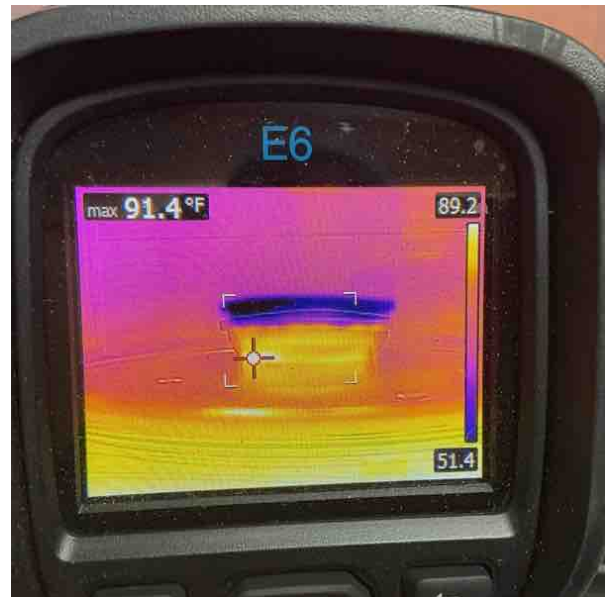
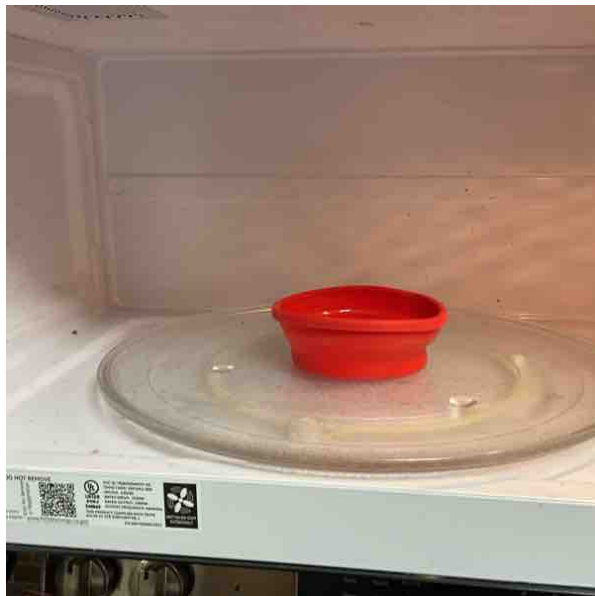
14.6.2 Microwave was tested and functional at time of inspection. **(Kitchen)**
